CONDITION REPORT

Report No: 2016207178

Vehicle Type	PASSENGER VEHICLE	Registered Owner	MFC
Manufacturer	HYUNDAI	Registration Number	NU138-273
Model	i20	Register Number	
VIN	MALBM51BLKM527718	Date Of First Licensing	
Engine Number		Last COR	
Doors	5	License Expiry Date	30/09/2023
Color	BLUE	Power / Displacement	
Year Model		Paint Finish	M - METALLIC
Km Reading	110,298 KM	Fuel	PETROL
Cab / Body Type	HATCHBACK	Transmission	MANUAL

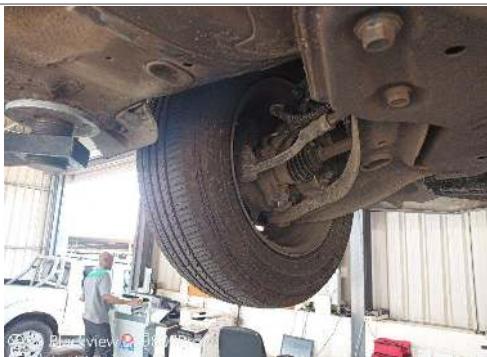
LF TYRE TREAD

Size	Load/Speed Index	Manufacture	Model	Type*	Production Date	Tread Depth (mm)
Front Left	185/70R14	88T	Winrun	R380	V	2122	3 mm
Front Right	185/70R14	88T	Dunlop	Sp sport	V	2822	4 mm
Rear Left	185/70R14	88T	Dunlop	Sp sport	V	2822	4 mm
Rear Right	185/70R14	88T	Dunlop	Sp sport	V	2822	4 mm
