CONDITION REPORT

Report No: 2016212397

MFC Auction House  
M57 Pretoria Rd, Glenmarais, KEMPTON PARK  
Gauteng

| Manufacturer | HYUNDAI | Registration Number | JP12VGGP |

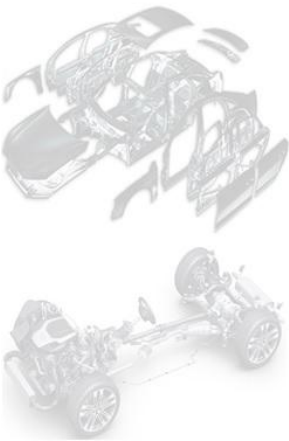
| Damage | Repair Way |
|---|---|
| Front Bumper Damaged | Repair |
| Bonnet Damaged | Repair |
| Rear Fender Right Damaged | Repair |
| Door Front Left Damaged | Repair |
| Door Rear Left Damaged | Repair |
