## CONDITION REPORT

Report No:  
2016959081  
DATE  
26/07/2025

Vehicle Type	PASSENGER VEHICLE	Registered Owner	MFC
Manufacturer	HYUNDAI	Registration Number	KJB281NW
Model	VENUE 1.0 88KW TGDI MOTION INFOTAINMENT [2020-2023]	Register Number	
VIN	MALFB81ALLM071768	Date Of First Licensing	
Engine Number		Last COR	
Doors	5	License Expiry Date	
Color	RED	Power / Displacement	
Year Model	2020	Paint Finish	TWO COAT METALLIC
Km Reading	181,956 KM	Fuel	PETROL
Cab / Body Type	HATCHBACK	Transmission	MANUAL

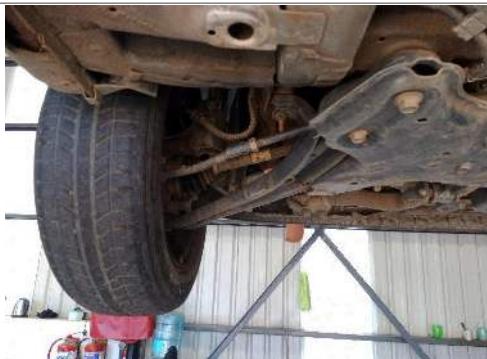
LF TYRE TREAD

Size	Load/Speed Index	Manufacture	Model	Type*	Production Date	Tread Depth (mm)
Front Left	195/65R15	91V	Dunlop	Sp	V	2222	0 mm
Front Right	195/50R15	82V	Joyride	Radial	V	0122	2 mm
Rear Left	185/65R15	88H	Winrun	Radial	V	2922	0 mm
Rear Right	185/65R15	88H	Dunlop	Sp	V	4321	0 mm

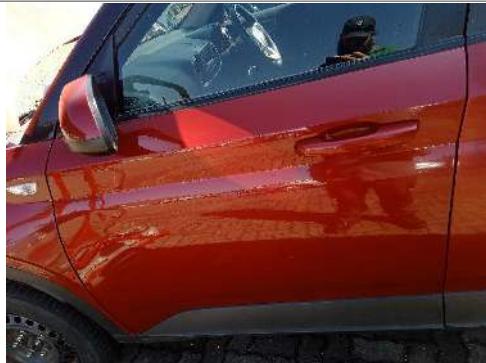
Door Front Left

General Comments: Engine Compartment: Battery loose.  
Interior: electronic mirrors adjusters do not work.  
Body • Exterior: Minor dents and scratches and stone chips to some body panels. Signs of repair work done to somebody panels. Poor alignment to somebody panels. Repair work done to vehicle below standard. Vehicle body in poor condition.
