MFC Auction House
M57 Pretoria Rd, Glenmarais, KEMPTON PARK
Gauteng

DEKRA MFC
M57 Pretoria Rd - 1619
KEMPTON PARK - GT
08610 33572

VEHICLE INSPECTION

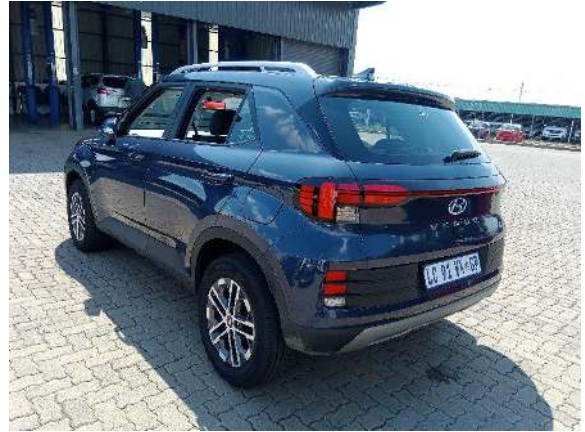
REAR LEFT CORNER

| Damage | Repair Way |
|---|---|
| Door Rear Left Dented | Repair |
