CONDITION REPORT

Report No: 201644863

DATE
10/07/2024

Vehicle Type	PASSENGER VEHICLE	Registered Owner	MFC AUCTION HOUSE
Manufacturer	HYUNDAI	Registration Number	LC71YZGP
Model	VENUE	Register Number	
VIN	MALFB81BLPM405603	Date Of First Licensing	
Engine Number		Last COR	
Doors	5	License Expiry Date	30/04/2024
Color	SILVER	Power / Displacement	
Year Model		Paint Finish	TWO COAT UNI
Km Reading	19,757 KM	Fuel	PETROL
Cab / Body Type	HATCHBACK	Transmission	MANUAL

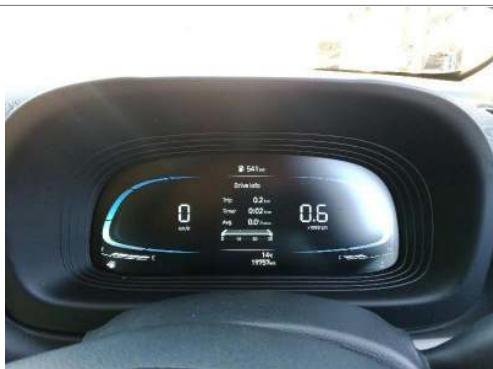
DASHBOARD (W/ ENGINE RUNNING)

No	System	Code	Description	Status
1	AB(AIRBAG)	B1102:00	BATTERY VOLTAGE LOW
