## CONDITION REPORT

Report No: 2016844468

| Manufacturer | HYUNDAI | Registration Number | JS42DSGP |
| Model | VENUE 1.0 88KW TGD1 FLUID 2 TONE [2020-2023] | Register Number | |

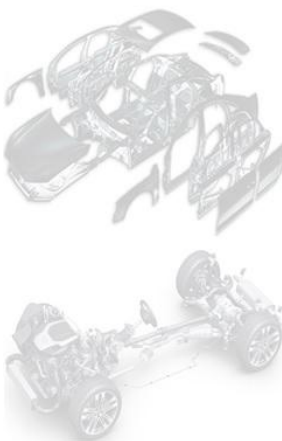
| Damage | Repair Way |
|---|---|
| Hoses Oil Leak | Repair |
| Seat Rear Defective | Repair |
| Side Mirror Left Residual Traces of Repair | Replace |
| Front Bumper Damaged | Repair |
| Bonnet Paintwork • Chipmarks | Repair |
| Front Fender Left Dented | Repair |
| Front Fender Right Residual Traces of Repair | Repair |
| Rear Fender Right Dented | Repair |
| Door Front Left Damaged | Repair |
| Door Front Right Dented | Repair |
| Door Rear Left Paintwork • Scratched | Repair |
| Door Rear Right Paintwork • Scratched | Repair |
| Boot Lid / Hatch door Paintwork • Scratched | Repair |
| Rear bumper Paintwork • Scratched | Repair |
| Windscreen Chipped | Repair |
| Shock Absorber Front Left Sweat | Replace |
| Shock Absorber Rear Left Sweat | Replace |
| Shock Absorber Rear Right Sweat | Replace |
| Tyre Rear Left Worn | Replace |

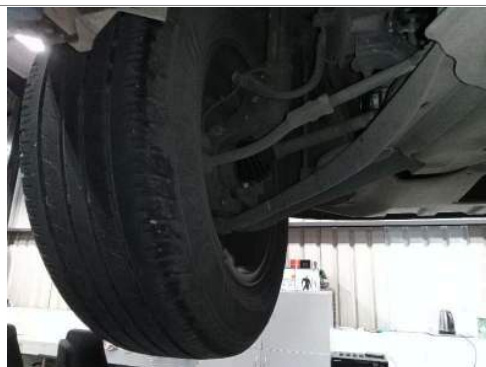
LF TYRE TREAD

| | Size | Load/Speed Index | Manufacture | Model | Type* | Production Date | Tread Depth (mm) |
|---|---|---|---|---|---|---|---|
| Front Left | 215/60 R16 | 95H | MRF | Wanderer | V | 0620 | 4 mm |

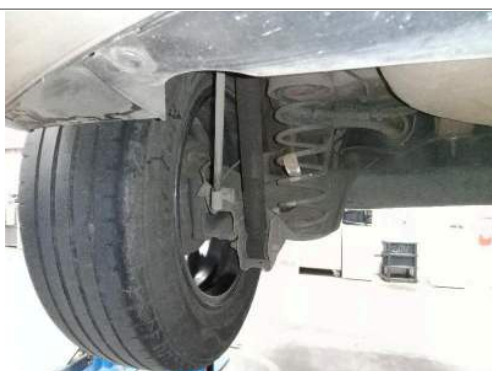
LR TYRE TREAD

| Damage | Repair Way |
|---|---|
| Rear tyres size differs | Replace |

| | Size | Load/Speed Index | Manufacture | Model | Type* | Production Date | Tread Depth (mm) |
|---|---|---|---|---|---|---|---|
| Rear Left | 215/65 R16 | 98H | Lanvigator | Comfort | V | 3121 | 0 mm |

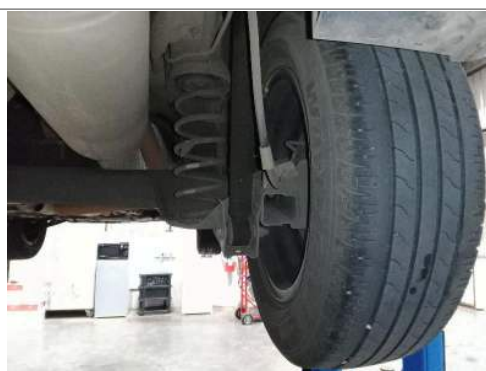
RR TYRE TREAD

| | Size | Load/Speed Index | Manufacture | Model | Type* | Production Date | Tread Depth (mm) |
|---|---|---|---|---|---|---|---|
| Rear Right | 215/60 R16 | 95H | MRF | Wanderer | | 0620 | 4 mm |

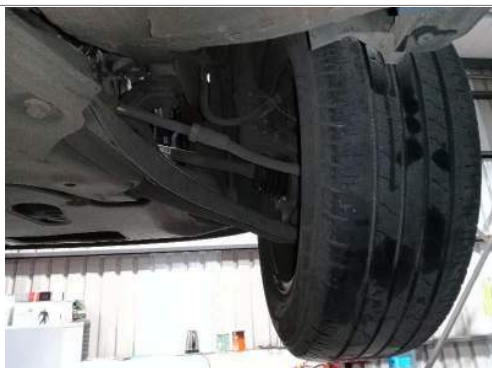
RF TYRE TREAD

| | Size | Load/Speed Index | Manufacture | Model | Type* | Production Date | Tread Depth (mm) |
|---|---|---|---|---|---|---|---|
| Front Right | 215/60 R16 | 95H | MRF | Wanderer | V | 0420 | 2 mm |
