## CONDITION REPORT

Report No:  
2017305215  
DATE  
30/09/2026

MFC Auction House  
M57 Pretoria Rd, Glenmarais, KEMPTON PARK  
Gauteng

| Manufacturer | TATA CARS | Registration Number | HYG076MP |

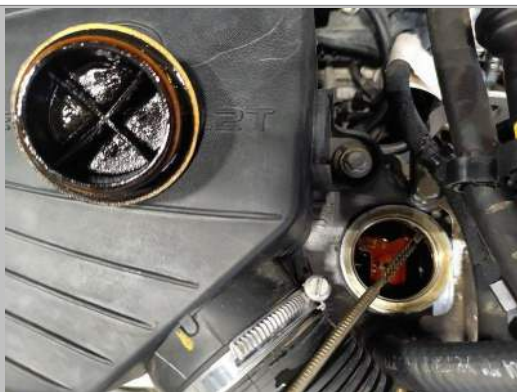
Oil cap and dipstick

| Engine Oil Sweat | Repair |

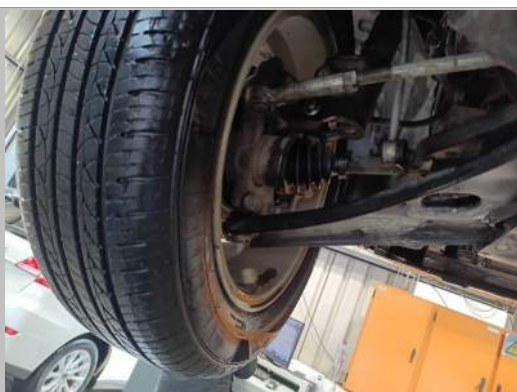
LF TYRE TREAD

| | Size | Load/Speed Index | Manufacture | Model | Type* | Production Date | Tread Depth (mm) |
|---|---|---|---|---|---|---|---|
| Front Left | 185/60R15 | 84H | Anchee | AC808 | V | 4225 | 5 mm |

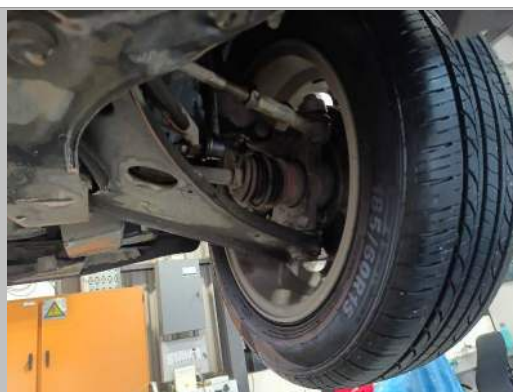
RF TYRE TREAD

| | Size | Load/Speed Index | Manufacture | Model | Type* | Production Date | Tread Depth (mm) |
|---|---|---|---|---|---|---|---|
| Front Right | 185/60R15 | 84H | Anchee | AC808 | V | 4425 | 4 mm |

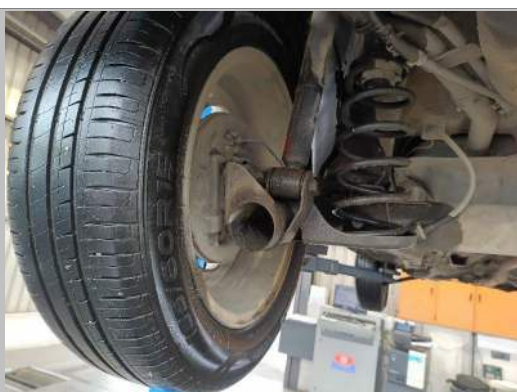
LR TYRE TREAD

| | Size | Load/Speed Index | Manufacture | Model | Type* | Production Date | Tread Depth (mm) |
|---|---|---|---|---|---|---|---|
| Rear Left | 185/60R15 | 84H | Royal black | Mile | V | 0624 | 5 mm |
