## CONDITION REPORT

Report No: 2016866280

DATE  
06/05/2025

| Manufacturer | SUZUKI | Registration Number | LN48KGGP |

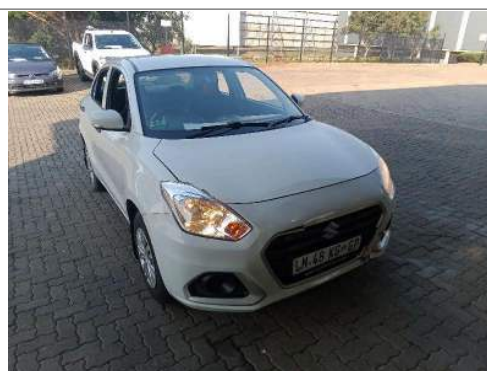
FRONT RIGHT CORNER

| Damage | Repair Way |
|---|---|
| Front Fender Right Dented | Repair |

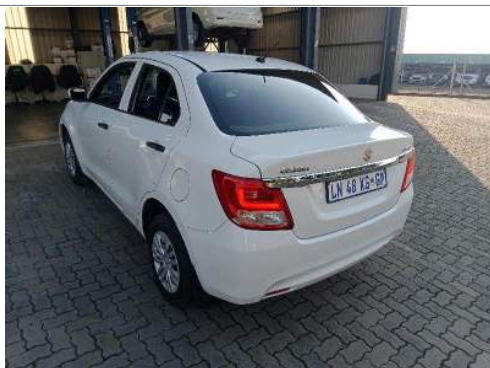
REAR LEFT CORNER

| Damage | Repair Way |
|---|---|
| Rear Fender Left Paintwork • Scratched | Repair |

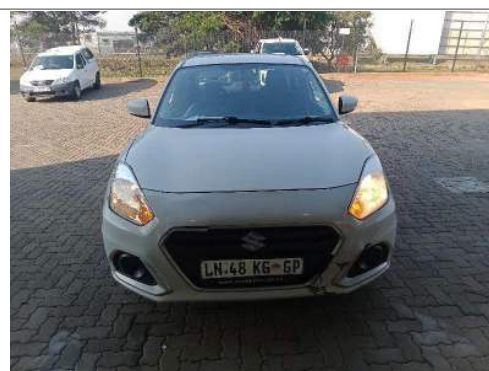
90 DEGREE FRONT

| Damage | Repair Way |
|---|---|
| Front Bumper Damaged | Repair |
| Grill Damaged | Replace |
| Windscreen Cracked | Replace |

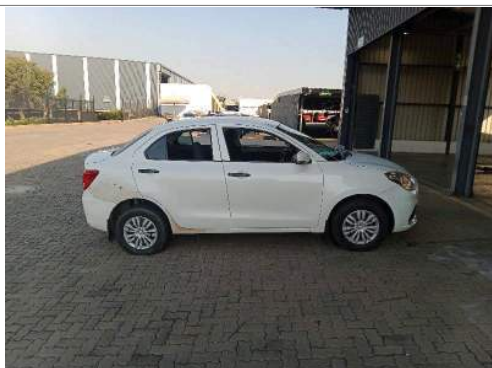
90 DEGREE RIGHT

| Damage | Repair Way |
|---|---|
| Door Front Right Paintwork • Scratched | Repair |
| Door Rear Right Paintwork • Scratched | Repair |
| Sill Panel Right Residual Traces of Repair | Repair |

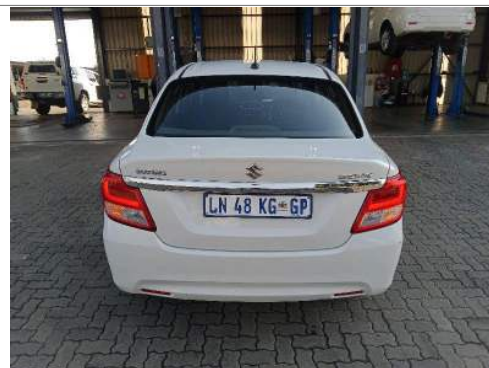
90 DEGREE REAR

| Damage | Repair Way |
|---|---|
| Boot Lid / Hatch door Dented | Repair |
| Rear bumper Paintwork • Scratched | Repair |

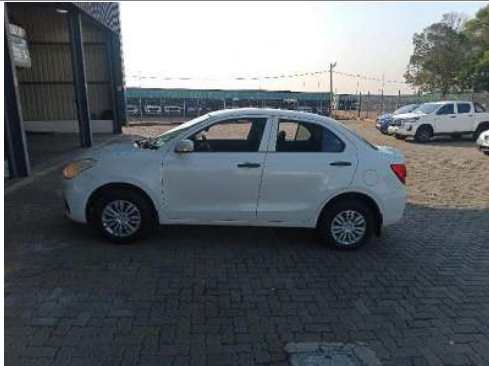
90 DEGREE LEFT

| Damage | Repair Way |
|---|---|
| Front Fender Left Dented | Repair |
| Door Front Left Dented | Repair |
| Door Rear Left Paintwork • Scratched | Repair |
| Sill Panel Left Dented | Repair |
