## CONDITION REPORT

Report No:  
2017302476  
DATE  
23/09/2026

| Manufacturer | SUZUKI | Registration Number | LV42ZMGP |
| Model | FRONX | Register Number | |

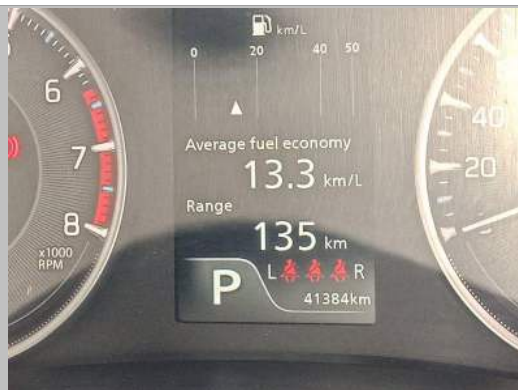
ODOMETER

| Km Reading | 41,384 KM | Fuel | PETROL |

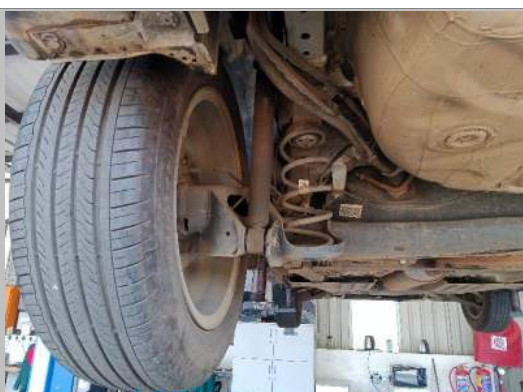
LR TYRE TREAD

| | Size | Load/Speed Index | Manufacture | Model | Type* | Production Date | Tread Depth (mm) |
|---|---|---|---|---|---|---|---|
| Rear Left | 195/60 R16 | 89H | Goodyear | Assurance | V | 1124 | 4 mm |

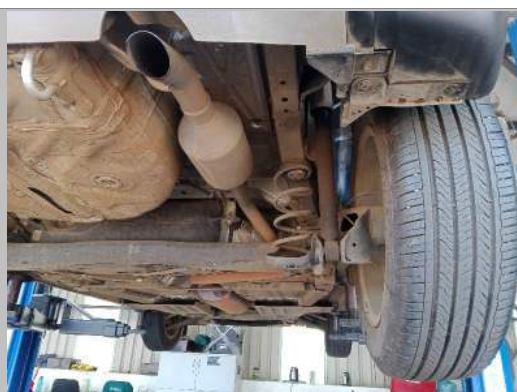
RR TYRE TREAD

| | Size | Load/Speed Index | Manufacture | Model | Type* | Production Date | Tread Depth (mm) |
|---|---|---|---|---|---|---|---|
| Rear Right | 195/60 R16 | 89H | Goodyear | Assurance | V | 1124 | 4 mm |

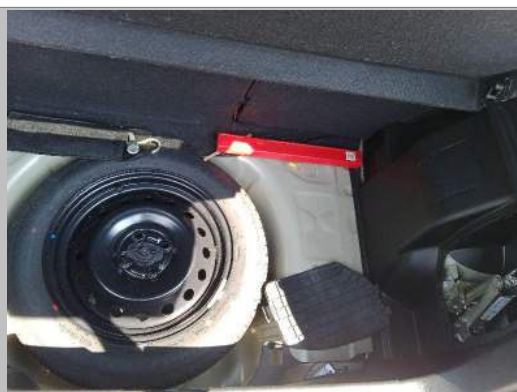
Spare Wheel and Accessories

| | Size | Load/Speed Index | Manufacture | Model | Type* | Production Date | Tread Depth (mm) |
|---|---|---|---|---|---|---|---|
| Spare | 195/60 R16 | 89H | Goodyear | Assurance | V | 0924 | 5 mm |
