## CONDITION REPORT

Report No:  
2016888250  
DATE  
23/05/2025

| Manufacturer | TOYOTA | Registration Number | KK83TWGP |
| Model | ETIOS 1.5 SPRINT [2019-2021] | Register Number | |

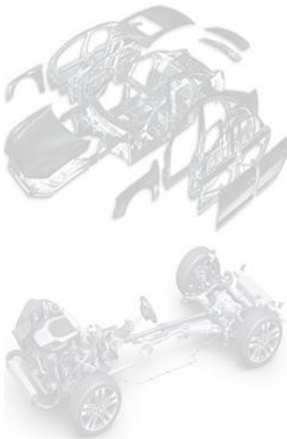
| Damage | Repair Way |
|---|---|
| Number Plate Light Right Missing | Replace |
| Side Mirror Right Paintwork • Dull | Repair |
| Front Bumper Damaged | Repair |
| Bonnet Paintwork • Dull | Repair |
| Front Fender Left Paintwork • Scratched | Repair |
| Rear Fender Left Paintwork • Dull | Repair |
| Rear Fender Right Paintwork • Scratched | Repair |
| Door Front Left Dented | Repair |
| Door Front Right Paintwork • Scratched | Repair |
| Door Rear Left Paintwork • Scratched | Repair |
| Rear bumper Paintwork • Scratched | Repair |
| Sill Panel Left Dented | Repair |

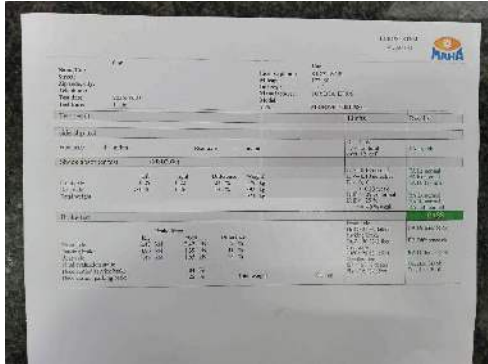
Shock and brake report

| | Left | Right | Axle Weight [KG] | Deceleration [m/s²] |
|---|---|---|---|---|
| Front | 2.4 | 2.4 | - | |
| Rear | 1.4 | 1.6 | - | |
| Emergency / Parking | 0.9 | 1.3 | - | |

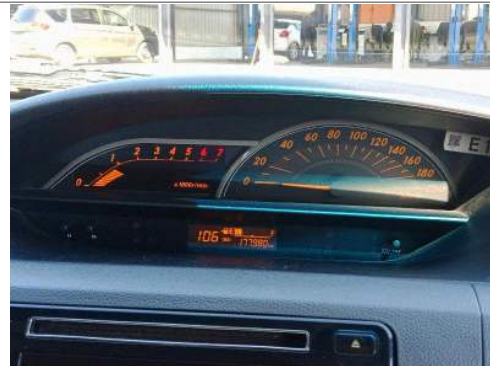
DASHBOARD (W/ ENGINE RUNNING)

| Damage | Repair Way |
|---|---|
| Vehicle electronics Faulty | Odometer and cluster lights malfunction |
| ABS warning lights malfunction | On and off |

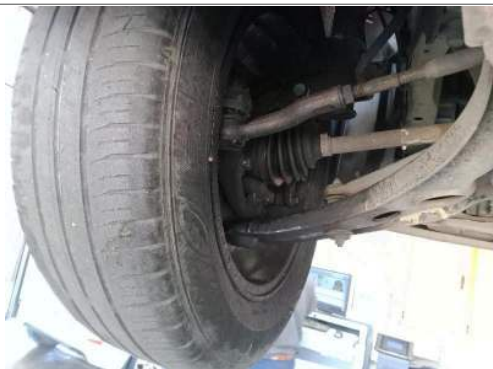
LF TYRE TREAD

| Damage | Repair Way |
|---|---|
| Tyre Front Left Smooth | Replace |

| | Size | Load/Speed Index | Manufacture | Model | Type* | Production Date | Tread Depth (mm) |
|---|---|---|---|---|---|---|---|
| Front Left | 185/65R15 | 88T | Dunlop | Enasave | V | 3322 | 0 mm |

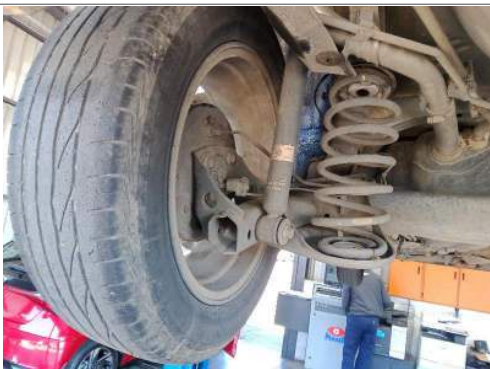
LR TYRE TREAD

| | Size | Load/Speed Index | Manufacture | Model | Type* | Production Date | Tread Depth (mm) |
|---|---|---|---|---|---|---|---|
| Rear Left | 185/60R15 | 84H | Bridgestone | Turanza | V | 0420 | 1 mm |

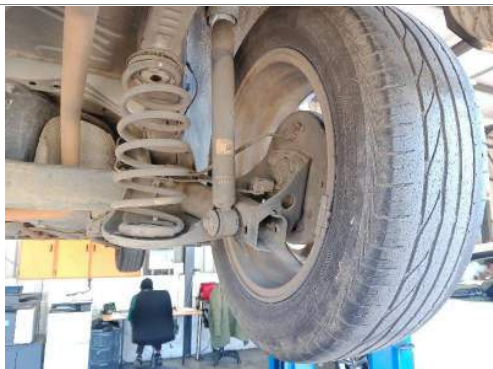
RR TYRE TREAD

| | Size | Load/Speed Index | Manufacture | Model | Type* | Production Date | Tread Depth (mm) |
|---|---|---|---|---|---|---|---|
| Rear Right | 185/60R15 | 84H | Bridgestone | --- | V | 0420 | 1 mm |

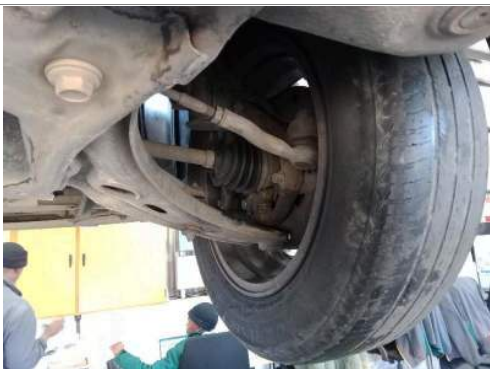
RF TYRE TREAD

| Damage | Repair Way |
|---|---|
| Tyre Front Right Smooth | Replace |

| | Size | Load/Speed Index | Manufacture | Model | Type* | Production Date | Tread Depth (mm) |
|---|---|---|---|---|---|---|---|
| Front Right | 185/65R15 | 88H | Firestone | Touring | V | 0000 | 0 mm |
