CONDITION REPORT

Report No: 2016360916

MFC Auction House
M57 Pretoria Rd, Glenmarais, KEMPTON PARK
Gauteng

Vehicle Type	PASSENGER VEHICLE	Registered Owner	MFC AUCTION HOUSE
Manufacturer	TOYOTA	Registration Number	KN79XCGP
Model	ETIOS	Register Number	
VIN	MBJB29BTX00121092	Date Of First Licensing	
Engine Number		Last COR	
Doors	4	License Expiry Date	31/05/2023
Color	WHITE	Power / Displacement	
Year Model		Paint Finish	TWO COAT UNI
Km Reading	202,533 KM	Fuel	PETROL
Cab / Body Type	SEDAN	Transmission	MANUAL

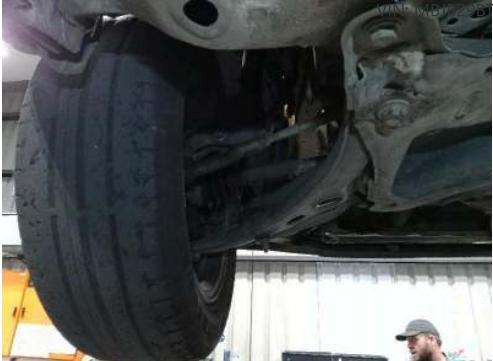
LF TYRE TREAD

Size	Load/Speed Index	Manufacture	Model	Type*	Production Date	Tread Depth (mm)
Front Left	185/60 R15	88H	Goodyear	Efficient	V	0719	0 mm
Front Right	185/60 R15	84H	Sumitomo	HTR H5	V	1921	0 mm
Rear Left	175/65 R15	88H	Zeta	Radial	V	3219	1 mm
Rear Right	175/65 R15	84H	Michelin	Energy	V	4116	1 mm
Spare	175/65 R15	84H	Hilo	HF201	V	0913	0 mm

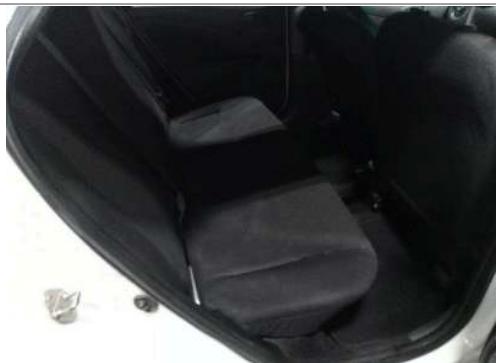
Damage	Repair Way
Fan Defective	Replace
Headlight Left Defective	Repair
Headlight Right Defective	Replace
Seat Front Right Damaged	Repair
Seat Rear Defective	Repair
Hood Lining Dirty	Repair
Door Sealing Rubber Front Right Damaged	Replace
Carpet Front Damaged	Repair
Steering Wheel Trim Defective	Repair
Side Mirror Left Paintwork • Scratched	Repair
Front Bumper Damaged	Repair
Bonnet Residual Traces of Repair	Repair
A • Pillar Right Dented	Repair
Front Fender Left Dented	Repair
Front Fender Right Dented	Repair
Rear Fender Left Damaged	Repair
Rear Fender Right Damaged	Repair
Door Front Left Residual Traces of Repair	Repair
Door Front Right Damaged	Repair
Door Rear Left Paintwork • Scratched	Repair
Door Rear Right Damaged	Repair
Doorstopper Front Right Defective	Replace
Doorstopper Rear Left Defective	Replace
Doorstopper Rear Right Defective	Replace
Boot Lid / Hatch door Dented	Repair
Rear bumper Damaged	Repair
Inner Boot Floor Pan and Spare Wheel Well Dented	Repair
