## CONDITION REPORT

Report No:  
2017210529  
DATE  
07/04/2026

Vehicle Type	PASSENGER VEHICLE	Registered Owner	MFC
Manufacturer	TOYOTA	Registration Number	FLN994L
Model	ETIOS 1.5 SPRINT 5-DR [2019-2021]	Register Number	
VIN	MBJM29BT102063399	Date Of First Licensing	
Engine Number		Last COR	
Doors	5	License Expiry Date	31/05/2023
Color	WHITE	Power / Displacement	
Year Model	2019	Paint Finish	TWO COAT UNI
Km Reading	85,274 KM	Fuel	PETROL
Cab / Body Type	HATCHBACK	Transmission	MANUAL

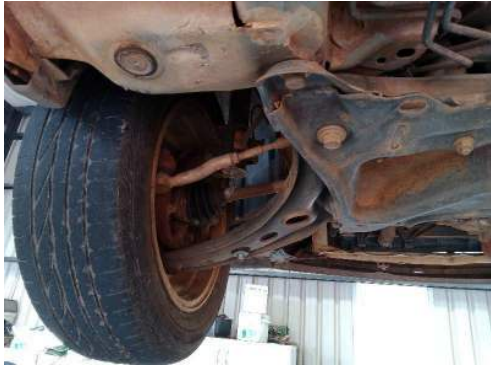
LF TYRE TREAD

Size	Load/Speed Index	Manufacture	Model	Type*	Production Date	Tread Depth (mm)
Front Left	185/60 R15	84H	Bridgestone	Turanza	V	0919	1 mm
Front Right	185/60 R15	84H	Bridgestone	Turanza	V	0919	1 mm
Rear Left	185/60 R15	84H	Bridgestone	Turanza	V	0919	0 mm
Rear Right	185/60 R15	84H	Bridgestone	Turanza	V	1219	0 mm
Spare	185/60 R15	84H	Bridgestone	Turanza	V	4919	6 mm

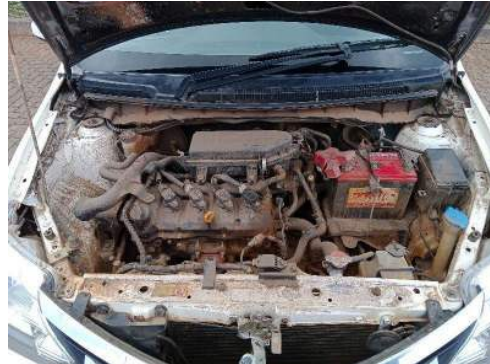
ENGINE 1

Damage	Repair Way
Engine Oil Sweat	Repair
Oil level Insufficient	Replace
Air cleaner Damaged	Replace
Hooter Defective	Repair
Windscreen Wiper Damaged	Replace
Air Conditioner Insufficient	Replace
Tail Light Right Defective	Replace
Headlight Right Damaged	Replace
Seat Rear Damaged	Repair
Sun Visor Left Cracked	Replace
Sun Visor Right Cracked	Replace
Hood Lining Damaged	Repair
Door Panel Front Left Damaged	Repair
Door Panel Front Right Damaged	Repair
Door Handle Rear Right Damaged	Replace
Dash Padding Damaged	Repair
Carpet Rear Torn / Cut	Repair
Front Bumper Damaged	Repair
Grill Damaged	Replace
Bonnet Residual Traces of Repair	Repair
Bonnet slam plate (Shock tower/ Inner tray) Damaged	Repair
A • Pillar Left Residual Traces of Repair	Repair
A • Pillar Right Residual Traces of Repair	Repair
B • Pillar Left Residual Traces of Repair	Repair
B • Pillar Right Residual Traces of Repair	Repair
C • Pillar Right Residual Traces of Repair	Repair

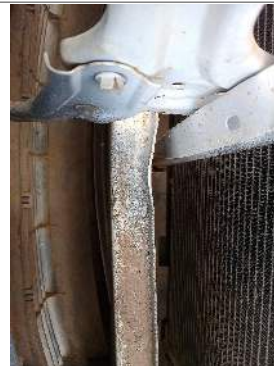
CV Joint(s) Boot(s) Front Right (inner/outer) Damaged	Replace
Radiator Cradle Damaged	Replace
Steering Malfunction	Repair
Brakes Insufficient	Repair
Interior	Front right inner A pillar plastic trim damaged
Body and Exterior	Front bumper stiffener dented

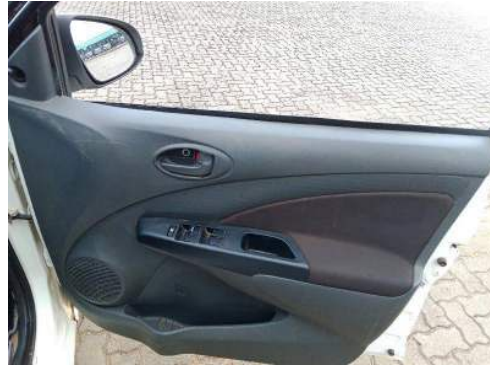
Door Panel Front Right

Front Fender Right Damaged	Repair
Rear Fender Left Dented	Repair
Front Fender Right / Inner Tray Damaged	Repair
Door Front Left Paintwork • Scratched	Repair
Door Front Right Damaged	Repair
Door Rear Left Residual Traces of Repair	Repair
Door Rear Right Paintwork • Scratched	Repair
Boot Lid / Hatch door Damaged	Repair
Rear bumper Residual Traces of Repair	Repair
Inner Boot Floor Pan and Spare Wheel Well Dented	Repair
Sill Panel Left Damaged	Repair
Sill Panel Right Dented	Repair
Roof Residual Traces of Repair	Repair
Service Brake Performance Rear Axle Left / Right	Repair
Difference out of legal range	
Shock Absorber Rear Right Leak	Replace
Alignment Poor Alignment	Repair
Control Arm Bush(es) Front Axle Left Cracked	Replace
Control Arm Bush(es) Front Axle Right Cracked	Replace
Tyre Rear Left Damaged	Replace
Tyre Rear Right Worn	Replace
Rim Front Left Scratched	Repair
Main Beam Right Dented	Repair
Chassis Welded	Repair

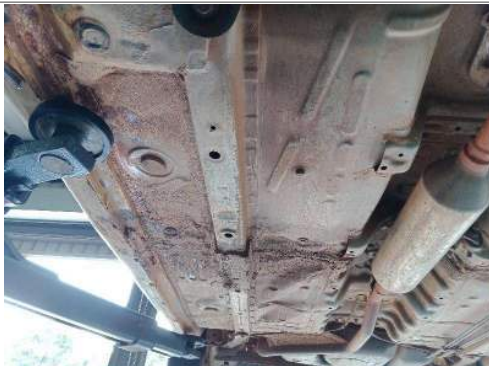
Chassis

Damage	Repair Way
Road test	Vehicle has a hard start
Airbag warning light illuminated on dashboard	Repair
Engine	Aircon condenser dented
Road test	Vehicle is a cut and joint on chassis
Road test	Vehicle safety integrity compromised
