CONDITION REPORT

Report No: 2016269378

Vehicle Type	PASSENGER VEHICLE	Registered Owner	MFC AUCTION HOUSE
Manufacturer	NISSAN	Registration Number	FZ83CBGP
Model	ALMERA	Register Number	
VIN	MDHBBAN17Z0718574	Date Of First Licensing	
Engine Number		Last COR	
Doors	4	License Expiry Date	29/02/2024
Color	SILVER	Power / Displacement	
Year Model		Paint Finish	M - METALLIC
Km Reading	328,332 KM	Fuel	PETROL
Cab / Body Type	SEDAN	Transmission	MANUAL

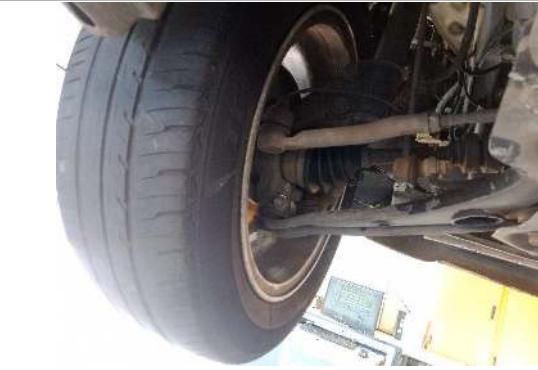
LF TYRE TREAD

Size	Load/Speed Index	Manufacture	Model	Type*	Production Date	Tread Depth (mm)
Front Left	185/60R15	84H	Firestone	Touring	V	1323	1 mm
Front Right	185/60R15	84H	Bridgestone	Potenza	V	3815	1 mm
Rear Left	205/60R15	91V	Pace	Pc20	V	4714	1 mm
Rear Right	195/60R15	88V	Continental	Contact	V	2116	1 mm

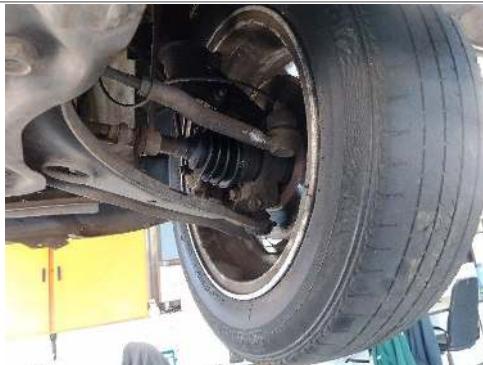
RF TYRE TREAD

Damage	Repair Way
Air cleaner Damaged	Replace
Park Light Front Left Defective	Repair
Park Light Front Right Defective	Repair
Park Light Rear Left Defective	Repair
Tail Light Left Broken	Replace
Tail Light Right Broken	Replace
Seat Front Left Torn / Cut	Replace
Rear Lower Valance Welded	Replace
Front Bumper Damaged	Replace
Grill Damaged	Replace
Bonnet slam plate (Shock tower/ Inner tray) Dented	Repair
Front Fender Left Dented	Repair
Front Fender Right Damaged	Repair
Door Front Left Dented	Repair
Door Rear Left Paintwork • Scratched	Repair
Rear bumper Damaged	Repair
Shock Absorber Front Left Leak	Replace
Control Arm Bush(es) Front Axle Right Cracked	Replace
Ball Joint(s) Front Axle Left Loose / Excessive Play	Replace
Ball Joint(s) Front Axle Right Loose / Excessive Play	Replace
Tyre Front Left Excessive Wear & Tear	Replace
Tyre Front Right Torn / Cut	Replace
Tyre Rear Right Smooth	Replace
Rim Rear Right Dented	Repair

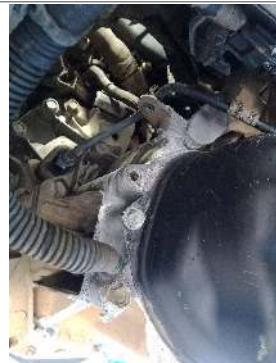
Bolt(s) / Nut(s) Rear Wheel Left Missing	Replace
Bolt(s) / Nut(s) Rear Wheel Right Missing	Replace
Belly plates Damaged	Replace
Gearbox Damaged	Repair
Rear tyre size differs.	Replace.
