MFC Auction House  
M57 Pretoria Rd, Glenmarais, KEMPTON PARK  
Gauteng

## Vehicle Data

Vehicle Type	PASSENGER VEHICLE	Registered Owner	
Manufacturer	NISSAN	Registration Number	JM15BWGP
Model	ALMERA 1.5 ACENTA [2016-2023]	Register Number	
VIN	MDHBBAN17Z0730286	Date Of First Licensing	
Engine Number		Last COR	
Doors	4	License Expiry Date	28/02/2026
Color	WHITE	Power / Displacement	
Year Model	2020	Paint Finish	C - COMMON
Km Reading	400,779 KM	Fuel	PETROL
Cab / Body Type	SEDAN	Transmission	MANUAL

## VEHICLE INSPECTION

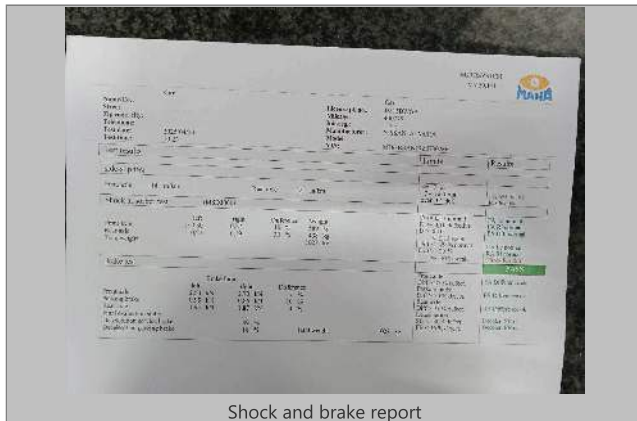
Shock and brake report

Left	Right		
	Braking Force [KN]	Braking Force [KN]	Axle Weight [KG]	Deceleration [m/s <sup>2</sup> ]
Front	2.5	2.7	-	
Rear	1.9	1.8	-	
Emergency / Parking	0.9	0.8	-

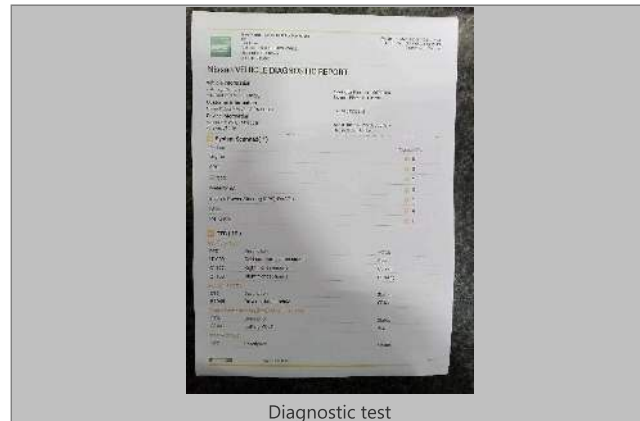
Diagnostic test

No	System	Code	Description	Status
1	ABS	C1107	RIGHT FRONT SENSOR 2

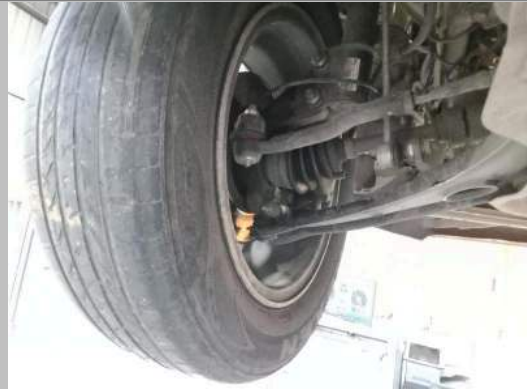
LF TYRE TREAD

Size	Load/Speed Index	Manufacture	Model	Type*	Production Date	Tread Depth (mm)
Front Left	195/65R15	91V	Nexen	Npriz	V	0000	0 mm
Front Right	195/65R15	91H	Continental	Contact	V	4522	1 mm
Rear Left	185/60R15	84H	Goodyear	Duragrip	V	0000	1 mm
Rear Right	195/60R15	88H	Firestone	Touring	V	4812	2 mm
Spare	185/65R15	91H	Goodyear	Excellence	V	0000	1 mm

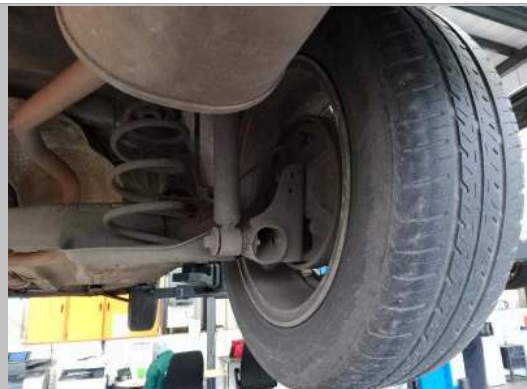
RR TYRE TREAD

Damage	Repair Way
Engine Oil Sweat	Repair
Air cleaner Damaged	Repair
Seat Front Right Torn / Cut	Repair
Front Bumper Damaged	Replace
Bonnet Residual Traces of Repair	Repair
A • Pillar Left Damaged	Repair
Front Fender Left Residual Traces of Repair	Repair
Front Fender Right Damaged	Repair
Rear Fender Left Dented	Repair
Door Front Left Residual Traces of Repair	Repair
Door Rear Left Residual Traces of Repair	Repair
Boot Lid / Hatch door Paintwork • Scratched	Repair
Rear bumper Paintwork • Scratched	Repair
Sill Panel Left Damaged	Repair
Roof Dented	Repair
Control Arm Bush(es) Front Axle Right Damaged	Replace
Ball Joint(s) Front Axle Right Damaged	Replace
Tyre Front Left Excessive Wear & Tear	Replace
Tyre Rear Left Excessive Wear & Tear	Replace
Tyre Rear Right Excessive Wear & Tear	Replace

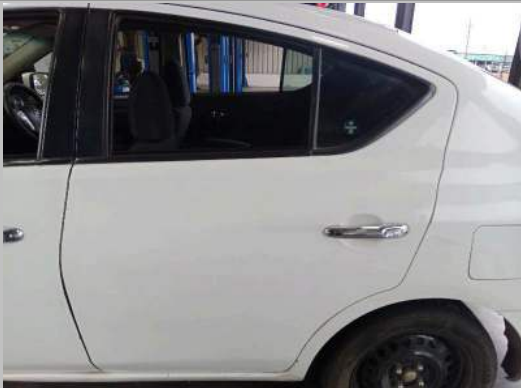
Door Rear Left

General Comments: ACCORDING TO THE AGE AND MILEAGE OF THE VEHICLE, NORMAL WEAR AND TEAR MARKS ARE VISIBLE ON THE INTERIOR, EXTERIOR, ELECTRICAL AND MECHANICAL PARTS. Body • Exterior: Residual traces of poor repair work most body panels. Signs of spray work done on some body panels. Minor dents scratches stone chips on some body panels.
