CONDITION REPORT

Report No: 2016866851

MFC Auction House
M57 Pretoria Rd, Glenmarais, KEMPTON PARK
Gauteng

Vehicle Type	PASSENGER VEHICLE	Registered Owner	
Manufacturer	NISSAN	Registration Number	KS84HTGP
Model	MAGNITE TURBO 1.0T ACENTA 5-DR CVT [2021-ON]	Register Number	
VIN	MDHFBADD0Z0006648	Date Of First Licensing	
Engine Number		Last COR	
Doors	5	License Expiry Date	31/07/2025
Color	SILVER	Power / Displacement	
Year Model	2022	Paint Finish	TWO COAT METALLIC
Km Reading	62,159 KM	Fuel	PETROL
Cab / Body Type	HATCHBACK	Transmission	AUTOMATIC

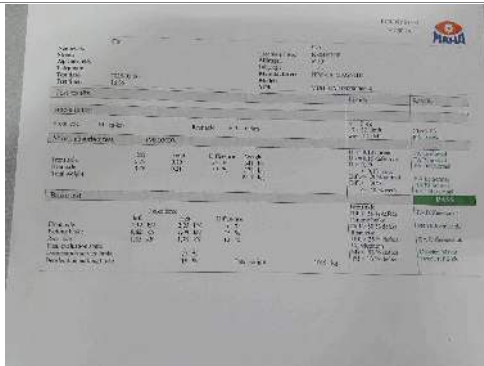
Brake and shock absorber

Left	Right		
	Braking Force [KN]	Braking Force [KN]	Axle Weight [KG]	Deceleration [m/s ²]
Front	2.12	2.25	-	
Rear	1.55	1.76	-	
Emergency / Parking	0.82	1.09	-
