MFC Auction House  
M57 Pretoria Rd, Glenmarais, KEMPTON PARK  
Gauteng

Vehicle Type	PASSENGER VEHICLE	Registered Owner	MFC
Manufacturer	NISSAN	Registration Number	KSF759MP
Model	MAGNITE	Register Number	
VIN	MDHFBADD0Z0007449	Date Of First Licensing	
Engine Number		Last COR	
Doors	5	License Expiry Date	31/10/2023
Color	RED	Power / Displacement	
Year Model		Paint Finish	TWO COAT METALLIC
Km Reading	18,070 KM	Fuel	PETROL
Cab / Body Type	HATCHBACK	Transmission	AUTOMATIC

## CONDITION REPORT

Report No: 2016212721

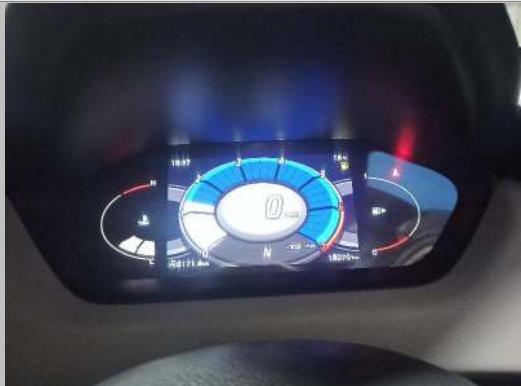
DASHBOARD (W/ ENGINE RUNNING)

During the diagnostic no active error messages were detected. (See also attached Diagnostic Report. For more information regarding the Fault Codes (DTC) and the recommended rectifications please contact the workshops of the vehicle manufacture).

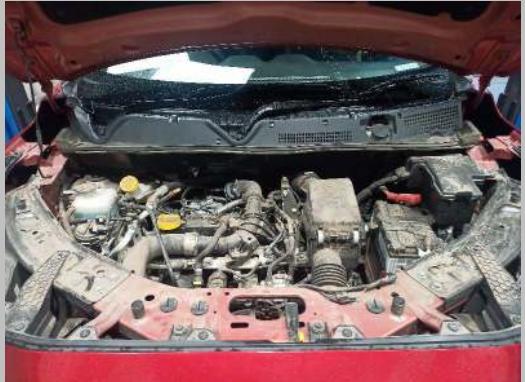
ENGINE 1

Engine number – not possible to verify engine number (not visible without dismantling)
