## CONDITION REPORT

Report No:  
2016996317  
DATE  
29/08/2025

Vehicle Type	PASSENGER VEHICLE	Registered Owner	MFC
Manufacturer	NISSAN	Registration Number	LJ55ZVGP
Model	MAGNITE TURBO 1.0T ACENTA PLUS 5-DR CVT [2022-2024]	Register Number	
VIN	MDHFBADD0Z0016332	Date Of First Licensing	
Engine Number		Last COR	
Doors	5	License Expiry Date	31/10/2025
Color	RED	Power / Displacement	
Year Model	2023	Paint Finish	TWO COAT UNI
Km Reading	44,352 KM	Fuel	PETROL
Cab / Body Type	HATCHBACK	Transmission	AUTOMATIC

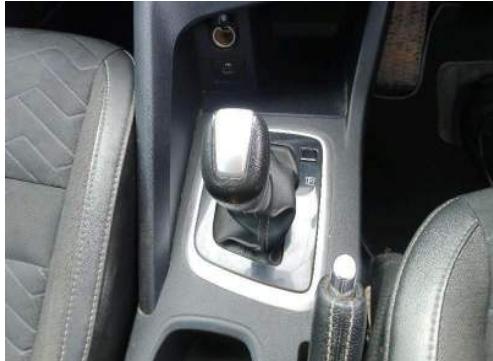
Automatic Transmission

No	System	Code	Description	Status
1	ABS	C1082:87	NO SEQUENTIAL GEARBOX MLTIPLEX SIG 2.DEF

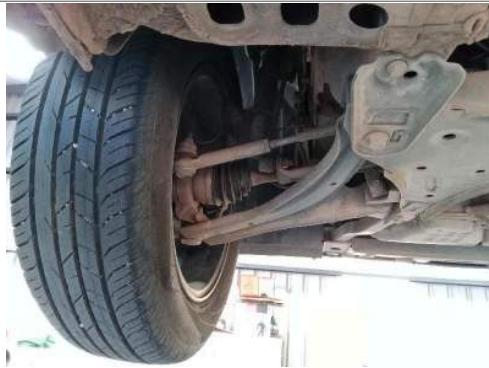
LF TYRE TREAD

Size	Load/Speed Index	Manufacture	Model	Type*	Production Date	Tread Depth (mm)
Front Left	195/60 R16	89V	Ceat	Secure drive	V	0423	6 mm
Front Right	195/60 R16	89V	Ceat	Secure drive	V	0423	3 mm
Rear Left	195/60 R16	89V	Ceat	Secure drive	V	0523	5 mm
Rear Right	195/60 R16	89V	Ceat	Secure drive	V	0423	5 mm
Spare	205/60 R16	96H	Davanti	DX390	V	2422	0 mm

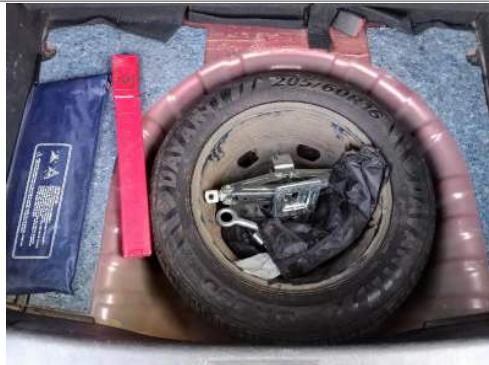
Spare wheel and Accessories

General Comments: ACCORDING TO THE AGE AND MILEAGE OF THE VEHICLE, NORMAL WEAR AND TEAR MARKS ARE VISIBLE ON THE INTERIOR, EXTERIOR, ELECTRICAL AND MECHANICAL PARTS. Engine Compartment: Engine bay dirty.  
Interior: Vehicle interior dirty and some panels scratched  
Body • Exterior: Minor dents and scratches on some body panels  
Tyres and Rims: Spare wheel regrooved.
