CONDITION REPORT

Report No:  
2017299055  
DATE  
15/09/2026

MFC Auction House  
M57 Pretoria Rd, Glenmarais, KEMPTON PARK  
Gauteng

| Model | MAGNITE 1.0 VISIA 5-DR [2023-2025] | Register Number | |

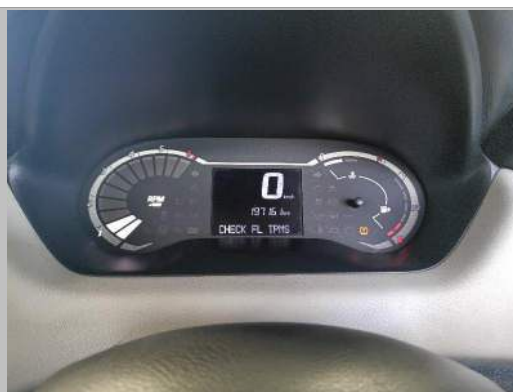
DASHBOARD (W/ ENGINE RUNNING)

| Warning lights illuminated | Repair |

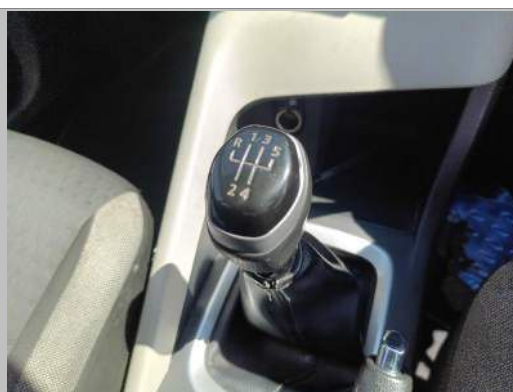
Manual transmission

| Clutch Operation Insufficient | Repair |

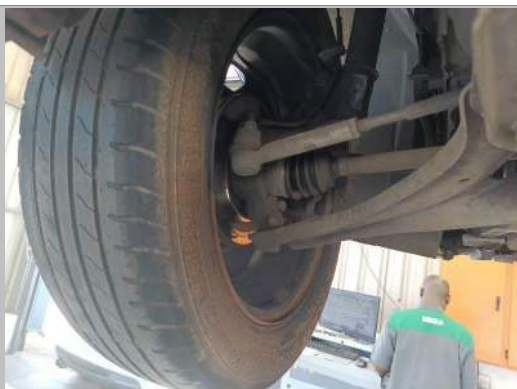
LF TYRE TREAD

| Tyre Front Left Excessive Wear & Tear | Replace |

| | Size | Load/Speed Index | Manufacture | Model | Type* | Production Date | Tread Depth (mm) |
|---|---|---|---|---|---|---|---|
| Front Left | 195/60R16 | 89H | MRF | Wanderer | V | 2621 | 0 mm |

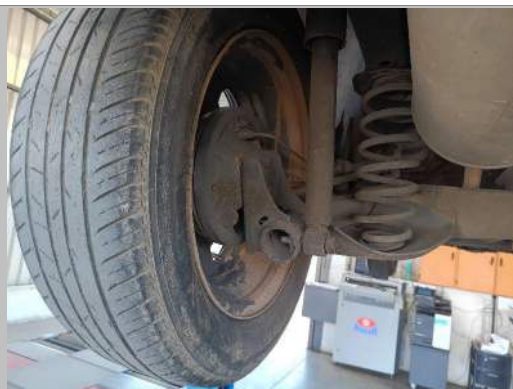
LR TYRE TREAD

| Tyre Rear Left Torn / Cut | Replace |

| | Size | Load/Speed Index | Manufacture | Model | Type* | Production Date | Tread Depth (mm) |
|---|---|---|---|---|---|---|---|
| Rear Left | 195/60R16 | 89V | Ceat | Securadrive | V | 2621 | 1 mm |

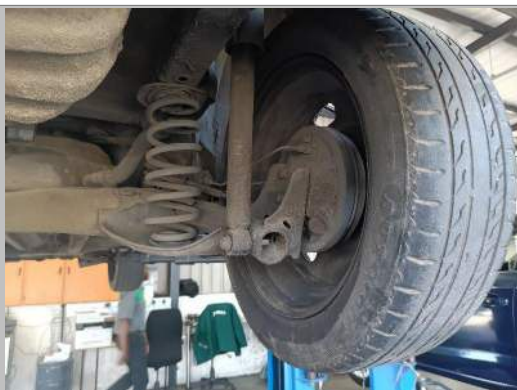
RR TYRE TREAD

| Tyre Rear Right Excessive Wear & Tear | Replace |

| | Size | Load/Speed Index | Manufacture | Model | Type* | Production Date | Tread Depth (mm) |
|---|---|---|---|---|---|---|---|
| Rear Right | 195/55R16 | 91V | Autogrip | Grip100 | V | | 0 mm |

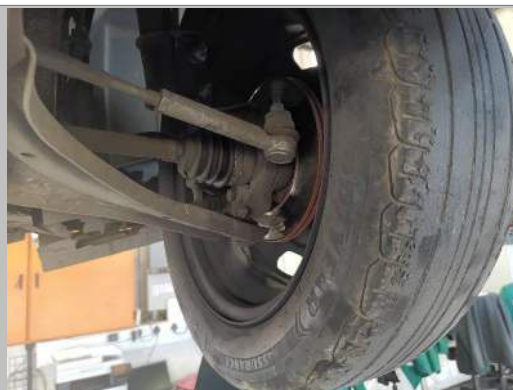
RF TYRE TREAD

| Tyre Front Right Smooth | Replace |

| | Size | Load/Speed Index | Manufacture | Model | Type* | Production Date | Tread Depth (mm) |
|---|---|---|---|---|---|---|---|
| Front Right | 195/55R6 | 87H | Goodyear | Eagle | V | 1722 | 0 mm |
