CONDITION REPORT

Report No: 2016569638

DATE  
14/10/2024

| Manufacturer | NISSAN | Registration Number | KZS501NW |

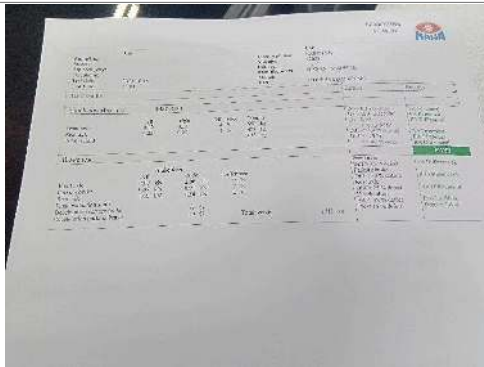
Brake and shock test

Brake Test Results

| | Left | Right | Axle Weight [KG] | Deceleration [m/s <sup>2</sup> ] |
|---|---|---|---|---|
| Front | 2.07 | 2.06 | - | |
| Rear | 1.6 | 1.54 | - | |
| Emergency / Parking | 0.97 | 0.91 | - | |

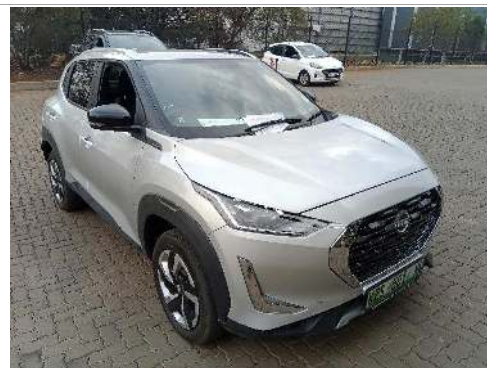
FRONT RIGHT CORNER

| Damage | Repair Way |
|---|---|
| Front Bumper Damaged | Repair |

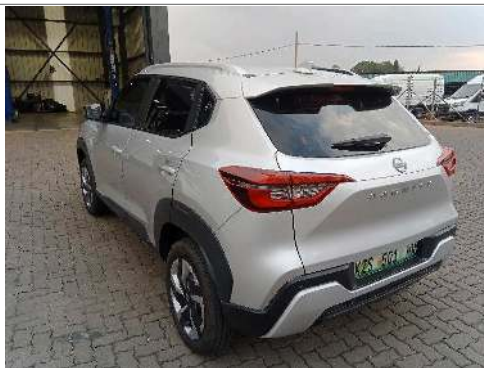
REAR LEFT CORNER

| Damage | Repair Way |
|---|---|
| Rear bumper Damaged | Repair |

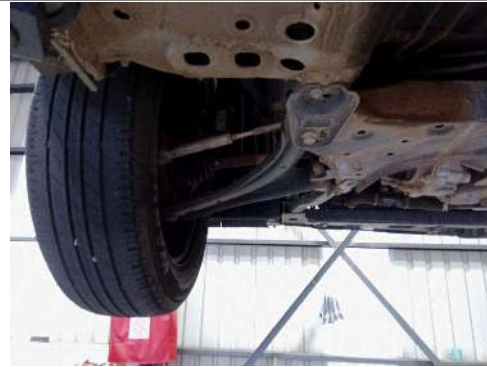
LF TYRE TREAD

| | Size | Load/Speed Index | Manufacture | Model | Type* | Production Date | Tread Depth (mm) |
|---|---|---|---|---|---|---|---|
| Front Left | 195/60R16 | 89H | MRF | Radial | V | 3223 | 3 mm |

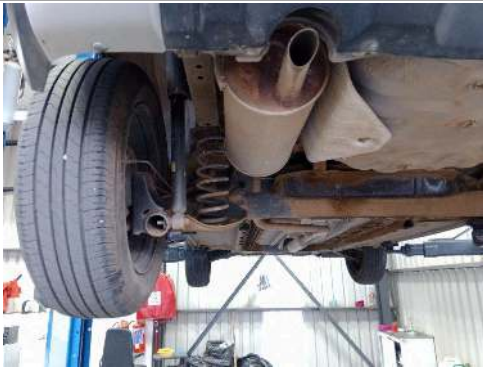
LR TYRE TREAD

| | Size | Load/Speed Index | Manufacture | Model | Type* | Production Date | Tread Depth (mm) |
|---|---|---|---|---|---|---|---|
| Rear Left | 195/60R16 | 89H | MRF | Radial | V | 3223 | 3 mm |

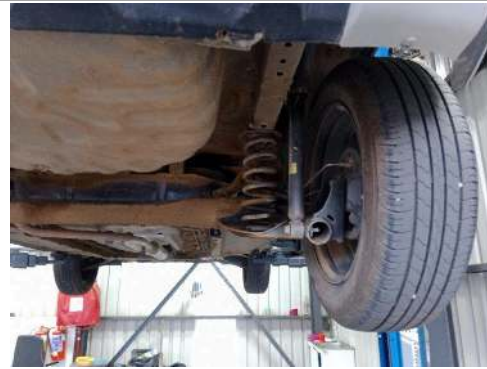
RR TYRE TREAD

| | Size | Load/Speed Index | Manufacture | Model | Type* | Production Date | Tread Depth (mm) |
|---|---|---|---|---|---|---|---|
| Rear Right | 195/60R16 | 86H | MRF | Radial | V | 3323 | 3 mm |

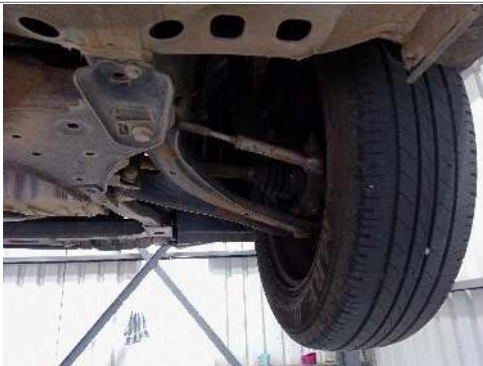
RF TYRE TREAD

| | Size | Load/Speed Index | Manufacture | Model | Type* | Production Date | Tread Depth (mm) |
|---|---|---|---|---|---|---|---|
| Front Right | 195/60R16 | 89H | MRF | Radial | V | 3223 | 3 mm |
