MFC Auction House
M57 Pretoria Rd, Glenmarais, KEMPTON PARK
Gauteng

Vehicle Type	PASSENGER VEHICLE	Registered Owner	MFC AUCTION HOUSE
Manufacturer	NISSAN	Registration Number	DKP643L
Model	MICRA	Register Number	
VIN	MDHFBUK13Z0516881	Date Of First Licensing	
Engine Number		Last COR	
Doors	5	License Expiry Date	07/02/2024
Color	BLUE	Power / Displacement	
Year Model		Paint Finish	TWO COAT UNI
Km Reading	238,956 KM	Fuel	PETROL
Cab / Body Type	HATCHBACK	Transmission	MANUAL

VEHICLE INSPECTION

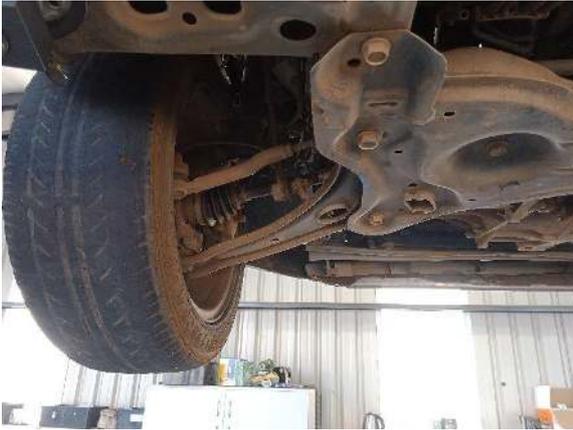
LF TYRE TREAD

Damage	Repair Way
Door Front Right Damaged	Repair
Door Rear Left Dented	Repair
Door Rear Right Damaged	Repair
Doorstopper Front Left Defective	Replace
Doorstopper Front Right Defective	Replace
Doorstopper Rear Left Defective	Replace
Doorstopper Rear Right Defective	Replace
Boot Lid / Hatch door Dented	Repair
Rear bumper Paintwork • Scratched	Repair
Inner Boot Floor Pan and Spare Wheel Well Dented	Repair
Sill Panel Left Paintwork • Scratched	Repair
Sill Panel Right Paintwork • Scratched	Repair
Rocker Panel Right Dented	Repair
Windscreen Cracked	Replace
Brake disc 1. Axle right Defective	Replace
Wheel bearing Front Left Loose / Excessive Play	Replace
Control Arm Bush(es) Front Axle Left Cracked	Replace
Control Arm Bush(es) Front Axle Right Cracked	Replace
Mounting Rubber(s) Rear Axle Left Cracked	Replace
Mounting Rubber(s) Rear Axle Right Cracked	Replace
Tyre Front Left Damaged	Replace
Tyre Front Right Worn	Replace

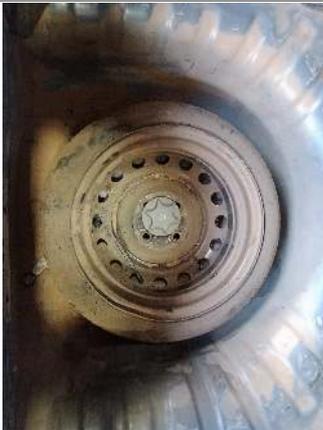
Spare wheel

Tyre Rear Left Defective	Replace
Spare Tyre Worn	Replace
Rim Front Right Dented	Repair
Rim Rear Left Dented	Repair
Rim Rear Right Dented	Repair
Rim Spare Wheel Dented	Repair
Main Beam Left Dented	Repair
Chassis Dented	Repair
Sub Frame Dented	Repair
Gearbox Mountings Welded	Replace
Gearbox Damaged	Repair
Radiator Cradle Damaged	Replace
Engine management light illuminated on dashboard	Repair

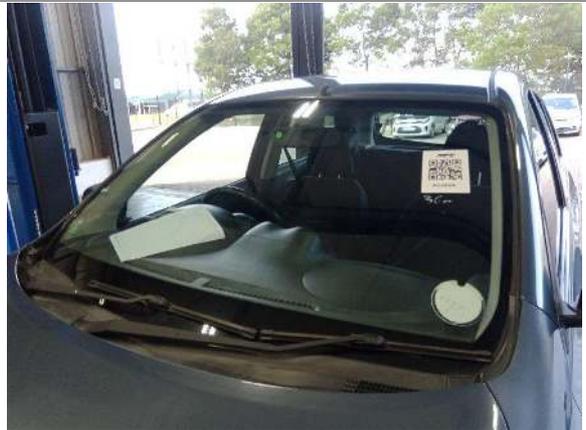
General Comments: VEHICLE HAS NO LICENSE DISC
Engine Compartment: Engine bay dirty.Brake fluid level ok.Battery loose.Corrosion on battery box and clamps.Oil sump dented.Aircon condenser loose.Radiator and Aircon condenser misaligned.
Interior: Vehicle interior d

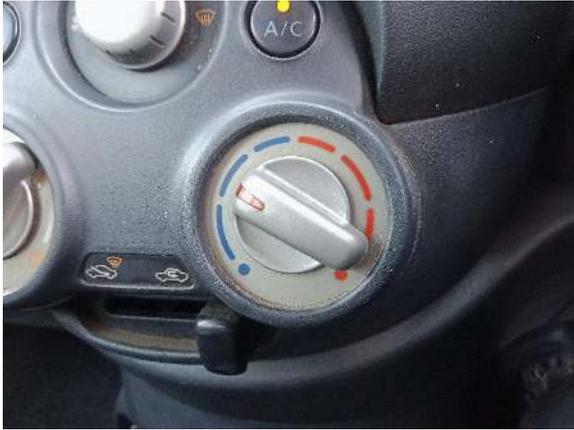
Damage	Repair Way
Engine Wiring Defective	Repair
Caps Missing	Replace
Fan Belt Defective	Replace
Battery clamps Defective	Repair
Air cleaner Defective	Repair
Heater control Defective	Replace
Windscreen Wiper Missing	Replace
Tail Light Left Defective	Replace
Headlight Left Defective	Replace
Headlight Right Defective	Replace
Seat Front Right Damaged	Repair
Seat Rear Defective	Repair
Hood Lining Defective	Repair
Door Sealing Rubber Front Right Damaged	Replace
Carpet Front Damaged	Repair
Boot Carpet Damaged	Replace
Steering Wheel Trim Defective	Repair
Number Plate Front Cracked	Replace
Number Plate Rear Damaged	Replace
Front Bumper Damaged	Repair
Bonnet Damaged	Repair
B • Pillar Left Paintwork • Scratched	Repair
B • Pillar Right Paintwork • Scratched	Repair
C • Pillar Right Dented	Repair
Front Fender Left Paintwork • Discoloured	Repair
Front Fender Right Damaged	Repair
Rear Fender Left Dented	Repair
Rear Fender Right Dented	Repair
