CONDITION REPORT

Report No:
2016963111
DATE
30/07/2025

Vehicle Type	PASSENGER VEHICLE	Registered Owner	MFC
Manufacturer	RENAULT	Registration Number	JF73NHGP
Model	KWID	Register Number	
VIN	MEEBBA007K7677937	Date Of First Licensing	
Engine Number		Last COR	
Doors	5	License Expiry Date	31/05/2022
Color	WHITE	Power / Displacement	
Year Model		Paint Finish	C - COMMON
Km Reading	137,839 KM	Fuel	PETROL
Cab / Body Type	HATCHBACK	Transmission	MANUAL

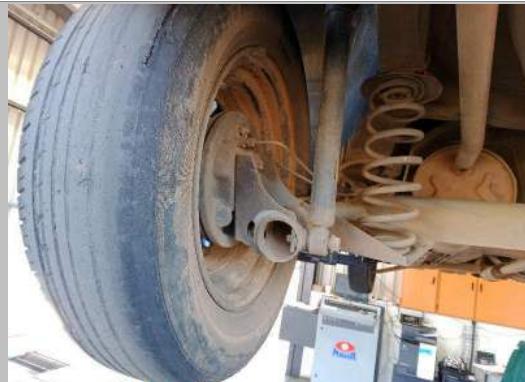
LR TYRE TREAD

Tyre Front Right Excessive Wear & Tear	Replace
Tyre Rear Left Excessive Wear & Tear	Replace
Tyre Rear Right Smooth	Replace
Spare Tyre Excessive Wear & Tear	Replace
Rim Front Right Dented	Repair
Main Beam Left Damaged	Repair
Engine to silencer pipe Welded	Repair
Silencer Welded	Repair
Gearbox Mountings Cracked	Replace
foreign substance on oil cap	Repair
exhaust system leak	Repair
Warning lights illuminated	Repair
Drive electric window not working	Repair

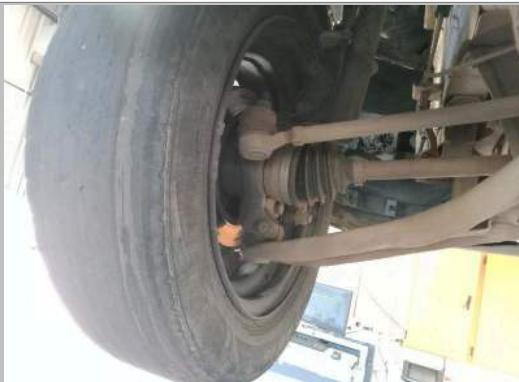
LF TYRE TREAD

Damage	Repair Way
Engine Oil Leak	Repair
Engine Wiring Defective	Repair
Switch Electrical Window Winder front right Defective	Repair
Tail Light Left Cracked	Replace
Headlight Left Cracked	Replace
Seat Front Left Torn / Cut	Repair
Seat Front Right Torn / Cut	Repair
Seat Rear Torn / Cut	Repair
Door Panel Front Right Damaged	Repair
Door Handle Front Right Damaged	Repair
Door Handle Rear Left Damaged	Replace
Parcel Tray Missing	Replace
Front Bumper Paintwork • Scratched	Repair
Bonnet Damaged	Repair
Front Fender Left Dented	Repair
Front Fender Right Paintwork • Scratched	Repair
Rear Fender Left Paintwork • Scratched	Repair
Rear Fender Right Paintwork • Scratched	Repair
Door Rear Left Paintwork • Scratched	Repair
Door Rear Right Dented	Repair
Boot Lid / Hatch door Dented	Repair
Windscreen Chipped	Replace
Control Arm Bush(es) Front Axle Left Damaged	Replace
Control Arm Bush(es) Front Axle Right Damaged	Replace
Tyre Front Left Excessive Wear & Tear	Replace

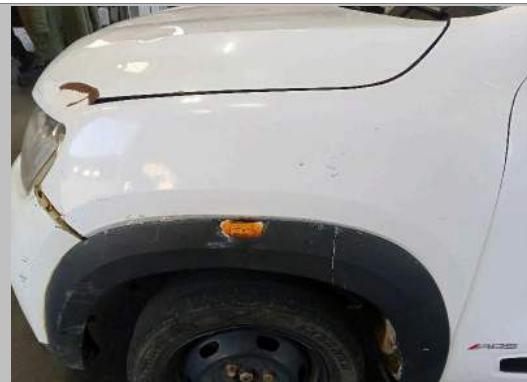
Front Fender Left

L/F fender liner missing
