MFC Auction House
M57 Pretoria Rd, Glenmarais, KEMPTON PARK
Gauteng

CONDITION REPORT

Report No: 2016524714

DATE
09/09/2024

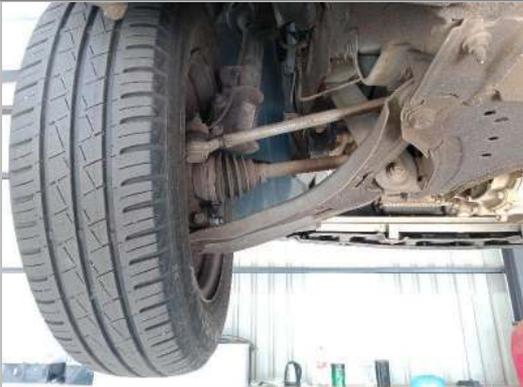
LF TYRE TREAD

Size	Load/Speed Index	Manufacture	Model	Type*	Production Date	Tread Depth (mm)
Front Left	185/70 R14	81T	Ceat	Fuelsmart	V	3720	4 mm
Front Right	165/70 R14	81T	Ceat	Fuelsmart	V	3820	4 mm
Rear Left	185/70 R14	81T	Ceat	Fuelsmart	V	3820	2 mm
Rear Right	185/70 R14	81T	Ceat	Fuelsmart	V	3820	1 mm
