## CONDITION REPORT

2017304888

| Manufacturer | REANULT | Registration Number | KM34JZGP |
| Model | KIGER | Register Number | |

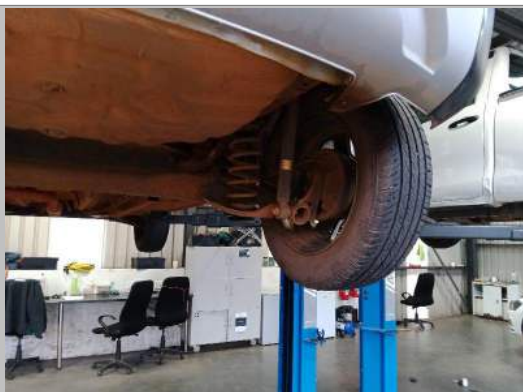
RR TYRE TREAD

| | Size | Load/Speed Index | Manufacture | Model | Type* | Production Date | Tread Depth (mm) |
|---|---|---|---|---|---|---|---|
| Rear Right | 205/60R16 | 92H | Autogrip | P308 plus | V | 3024 | 3 mm |

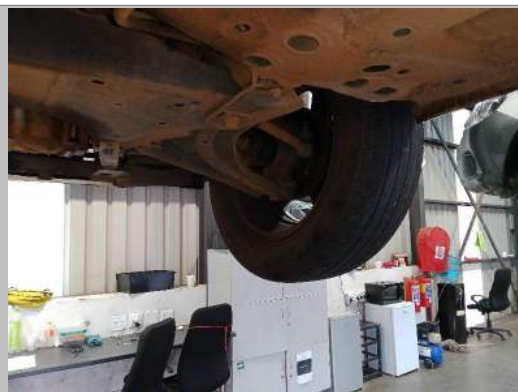
RF TYRE TREAD

| | Size | Load/Speed Index | Manufacture | Model | Type* | Production Date | Tread Depth (mm) |
|---|---|---|---|---|---|---|---|
| Front Right | 205/60R16 | 92H | Autogrip | P308 plus | V | 3024 | 1 mm |

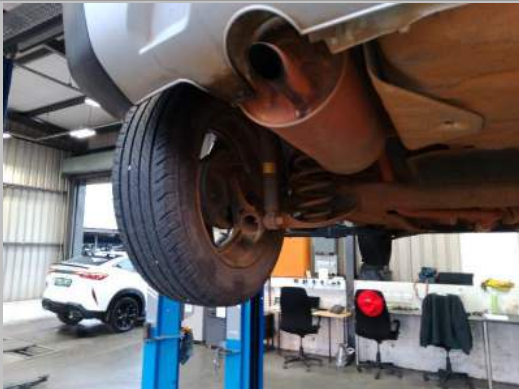
LR TYRE TREAD

| | Size | Load/Speed Index | Manufacture | Model | Type* | Production Date | Tread Depth (mm) |
|---|---|---|---|---|---|---|---|
| Rear Left | 205/60R16 | 92H | Autogrip | P308 plus | V | 3024 | 3 mm |

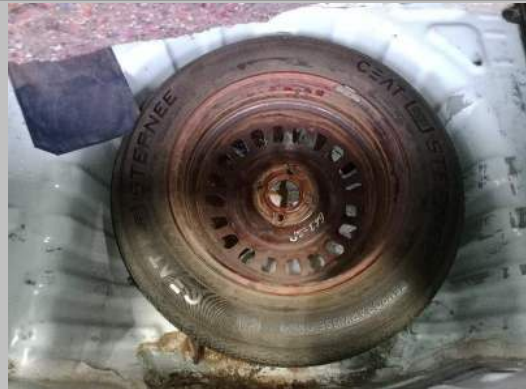
Spare wheel

| | Size | Load/Speed Index | Manufacture | Model | Type* | Production Date | Tread Depth (mm) |
|---|---|---|---|---|---|---|---|
| Spare | 185/65R15 | 88R | Ceat | Stepnee | V | 0000 | 4 mm |

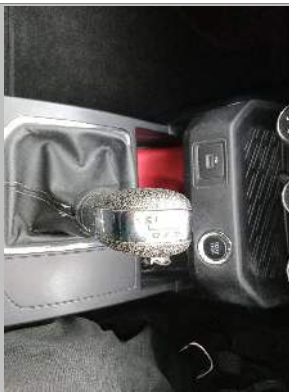
Automatic

| Gearbox Oil Sweat | Repair |

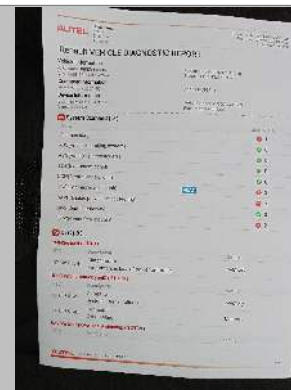
DIAGNOSTIC REPORT PAGE 1

During the diagnostic the following error messages were detected: (See also attached Diagnostic Report. For more information regarding the Fault Codes (DTC) and the recommended rectifications please contact the workshops of the vehicle manufacture).

| No | System | Code | Description | Status |
|---|---|---|---|---|
| 1 | MEMORY | DTC090174 | CLUTCH MOTOR PERFORMANCE LOSS OF POWER OR TORQUE | |
