CONDITION REPORT

Report No:
2016958188
DATE
25/07/2025

| Manufacturer | RENAULT | Registration Number | LB77HTGP |
| Model | TRIBIER | Register Number | |

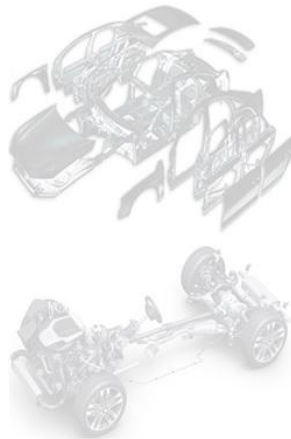
| Front Bumper Damaged | Repair |
| Bonnet Damaged | Repair |
| Front Fender Left Damaged | Repair |
| Front Fender Right Damaged | Repair |
| Rear Fender Right Damaged | Repair |
| Door Front Left Damaged | Repair |
| Door Front Right Damaged | Repair |
| Door Rear Left Damaged | Repair |
| Door Rear Right Damaged | Repair |
| Boot Lid / Hatch door Damaged | Repair |
| Rear bumper Damaged | Repair |

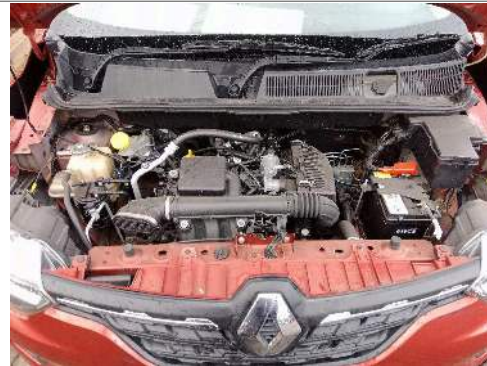
ENGINE 1

| Engine Performance Insufficient | Repair |
| Engine Noise Idling / Hunting | Repair |
