CONDITION REPORT

Report No: 2016480482

MFC Auction House
M57 Pretoria Rd, Glenmarais, KEMPTON PARK
Gauteng

Vehicle Type	PASSENGER VEHICLE	Registered Owner	
Manufacturer	TOYOTA	Registration Number	HL05PLGP
Model	AVANZA	Register Number	
VIN	MHKM5FA2N0K007803	Date Of First Licensing	
Engine Number		Last COR	
Doors	5	License Expiry Date	28/02/2022
Color	WHITE	Power / Displacement	
Year Model		Paint Finish	TWO COAT METALLIC
Km Reading	243,777 KM	Fuel	PETROL
Cab / Body Type	STATION WAGON	Transmission	MANUAL

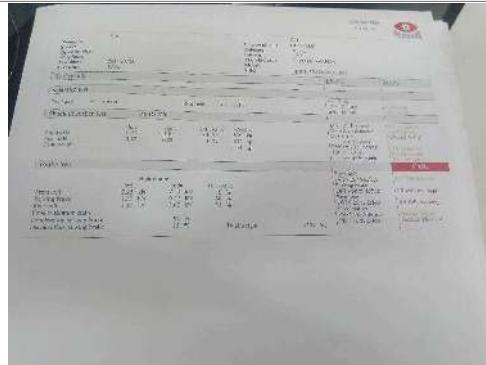
Brake and shock test

Left	Right	Axle Weight [KG]	Deceleration [m/s ²]
	Braking Force [KN]	Braking Force [KN]		
Front	2.25	2.14	-	
Rear	2.02	3.02	-	
Emergency / Parking	1.3	0.42	-

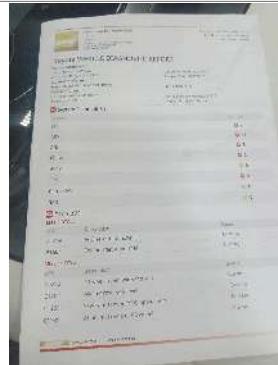
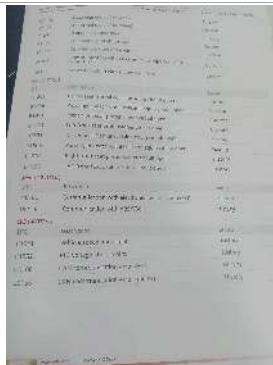
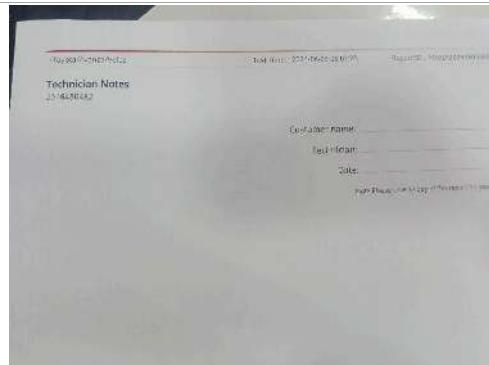
Diagnostics

No	System	Code	Description	Status
1	EFI	P1604	ENGINE START ABNORMAL

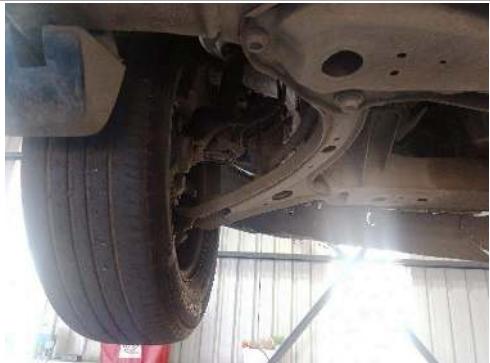
LF TYRE TREAD

Size	Load/Speed Index	Manufacture	Model	Type*	Production Date	Tread Depth (mm)
Front Left	185/70R14	88T	Zextour	Radial	V	0322	0 mm
Front Right	185/70R14	88T	Dunlop	Sp	V	1321	1 mm
Rear Left	185/70R14	88T	Tracmax	Radial	V	4722	2 mm
Rear Right	185/70R14	88T	Tracmax	Radial	V	4722	2 mm

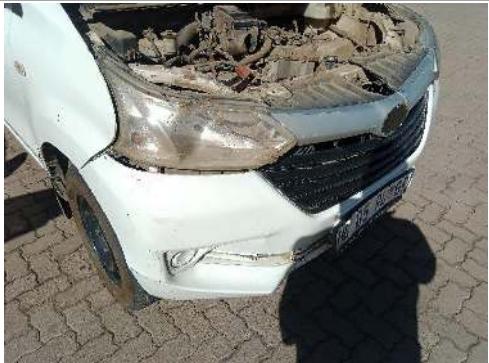
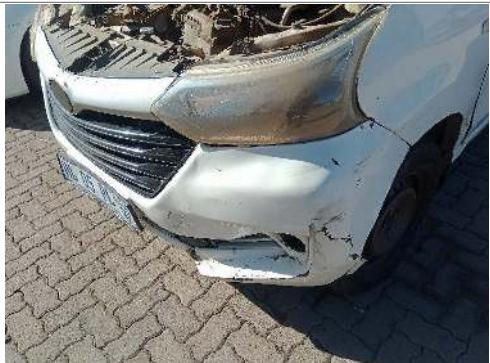
Front Bumper

Damage	Repair Way
Rear bumper Damaged	Repair
Windscreen Damaged	Replace
Brake disc 1. Axle left Worn	Replace
Brake disc 1. Axle right Worn	Replace
Shock Absorber Rear Left Worn	Replace
Tyre Front Left Worn	Repair
Main Beam Left Welded	Repair
Gearbox Oil Leak	Repair
Radiator Cross Member Damaged	Replace
Brakes Insufficient	Repair
Engine Performance Insufficient	Repair
Clutch Operation Slippy Hesitation	Replace
Body and exterior	Cut and join
Engine	Battery loose
interior	vehicle air bags deployed
Body and exterior	Signs of stone chips to some body panels.
Body and exterior	Signs of repair work done to somebody panels.
Body and exterior	Signs of impact damage to front of vehicle

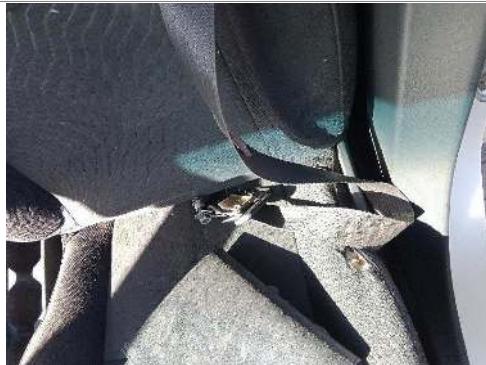
Damage	Repair Way
Engine Oil Leak	Repair
Fan Belt Damaged	Replace
Radiator Damaged	Replace
Air conditioner pipes Damaged	Replace
Engine Management Lights Set	Replace
Seat Front Left Damaged	Repair
Seat Front Right Damaged	Repair
Seat Rear Damaged	Repair
Seat Rear (2. Row) Damaged	Repair
Seat Belt Front Left Damaged	Repair
Seat Belt Front Right Damaged	Repair
Dash Padding Damaged	Repair
Carpet Front Damaged	Repair
Carpet Rear Damaged	Repair
Steering Wheel Trim Damaged	Repair
Side Mirror Left Damaged	Replace
Side Mirror Right Damaged	Replace
Front Bumper Damaged	Repair
Bonnet Damaged	Replace
Bonnet slam plate (Shock tower/ Inner tray) Damaged	Repair
Front Fender Left Damaged	Repair
Front Fender Right Damaged	Repair
Rear Fender Left Damaged	Repair
Rear Fender Right Damaged	Repair
Door Front Left Damaged	Repair
Door Front Right Damaged	Repair
Door Rear Left Damaged	Repair
Door Rear Right Damaged	Repair
Boot Lid / Hatch door Damaged	Repair
