Vehicle Type	PASSENGER VEHICLE	Registered Owner	MFC
Manufacturer	TOYOTA	Registration Number	HP47DBGP
Model	AVANZA	Register Number	
VIN	MHKM5FA2N0K007975	Date Of First Licensing	
Engine Number		Last COR	
Doors	5	License Expiry Date	30/04/2023
Color	GOLDEN	Power / Displacement	
Year Model		Paint Finish	TWO COAT METALLIC
Km Reading	376,610 KM	Fuel	PETROL
Cab / Body Type	STATION WAGON	Transmission	MANUAL

CONDITION REPORT

Report No: 2016213531

DATE
28/12/2023

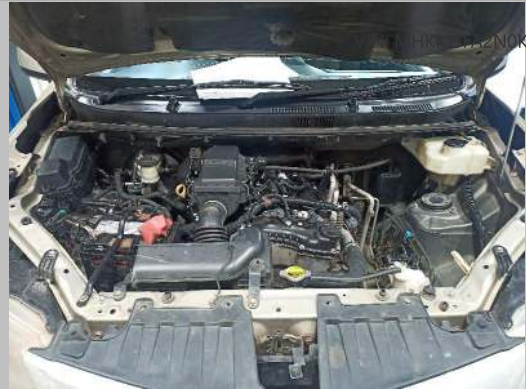
ENGINE 1

Damage	Repair Way
Engine Oil Leak	Repair
Engine Wiring Damaged	Replace
Fan Belt Worn	Replace
Central Air Vent Damaged	Repair
Electrical Window Winder front right Defective	Replace
Tail Light Left Damaged	Replace
Tail Light Right Damaged	Replace
Headlight Right Damaged	Replace
Seat Front Left Damaged	Repair
Seat Front Right Damaged	Repair
Seat Rear Damaged	Repair
Seat Rear (2. Row) Damaged	Repair
Sun Visor Right Damaged	Replace
Hood Lining Damaged	Repair
Door Panel Front Left Damaged	Replace
Door Panel Front Right Damaged	Replace
Carpet Rear Damaged	Replace
Steering Wheel Trim Worn	Repair
Side Mirror Right Damaged	Replace
Front Bumper Damaged	Repair
Grill Damaged	Replace
Bonnet Damaged	Repair
Front Fender Left Damaged	Replace
Front Fender Right Damaged	Repair
Rear Fender Left Damaged	Repair
Rear Fender Right Damaged	Repair
Door Front Left Damaged	Repair
Door Front Right Damaged	Repair
Door Rear Left Damaged	Repair

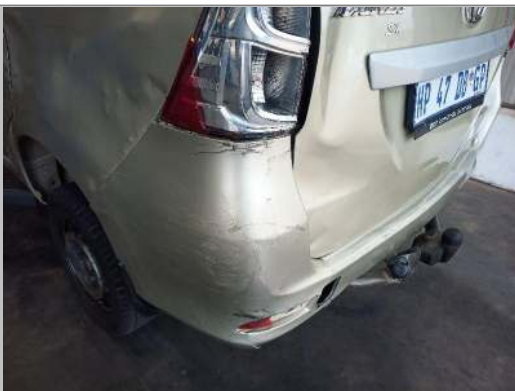
Damage	Repair Way
Door Rear Right Damaged	Repair
Boot Lid / Hatch door Damaged	Repair
Rear bumper Damaged	Repair
Sill Panel Left Damaged	Repair
Sill Panel Right Damaged	Repair
Windscreen Damaged	Replace
Service Brake Performance Rear Axle Left / Right	Repair
Difference out of legal range	
Parking Brake Performance Insufficient	Repair
Shock Absorber Rear Right Worn	Replace
Shock Absorber Mounting Front Right Damaged	Replace
Wheel bearing Rear Right Worn	Replace
Bolt(s) / Nut(s) Rear Wheel Right Damaged	Replace
Gearbox Oil Leak	Repair

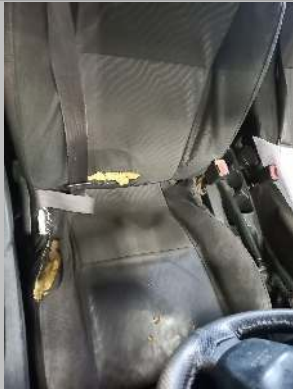
Seat Front Right

Interior: Interior panic handles missing and damaged. Vehicle interior in poor condition. Some interior panels damaged.
