## CONDITION REPORT

Report No: 2016859990

MFC Auction House  
M57 Pretoria Rd, Glenmarais, KEMPTON PARK  
Gauteng

Vehicle Type	PASSENGER VEHICLE	Registered Owner	
Manufacturer	TOYOTA	Registration Number	KMJ344MP
Model	AVANZA 1.5 SX MPV [2019-2022]	Register Number	
VIN	MHKM5FA2N0K013298	Date Of First Licensing	
Engine Number		Last COR	
Doors	5	License Expiry Date	31/01/2026
Color	SILVER	Power / Displacement	
Year Model	2020	Paint Finish	TWO COAT METALLIC
Km Reading	338,572 KM	Fuel	PETROL
Cab / Body Type	HATCHBACK	Transmission	MANUAL

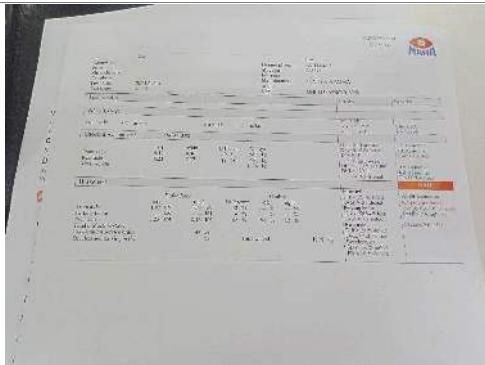
Brake test

Left	Right	Axle Weight [KG]	Deceleration [m/s <sup>2</sup> ]
	Braking Force [kN]	Braking Force [kN]		
Front	1.97	2.23	-	
Rear	1.25	0.16	-	
Emergency / Parking	0	0	-

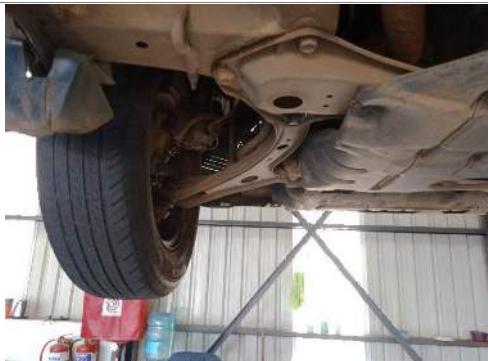
LF TYRE TREAD

Size	Load/Speed Index	Manufacture	Model	Type*	Production Date	Tread Depth (mm)
Front Left	185/70R14	88H	Autogrip	Radial	V	2424	2 mm
Front Right	185/70R14	88H	Autogrip	Radial	V	2424	2 mm
Rear Left	185/70R14	88H	Voyager	Radial	V	4222	3 mm
Rear Right	185/70R14	88H	Voyager	Radial	V	4422	3 mm

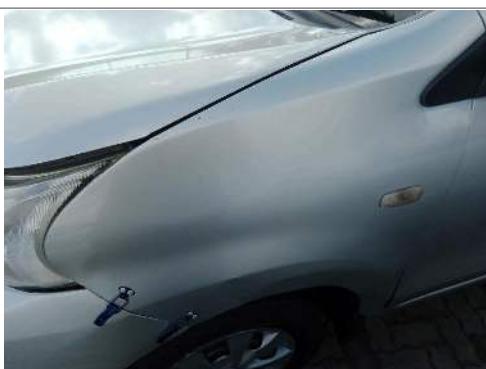
Damage	Repair Way
Bonnet stay and shocks Missing	Replace
Central Air Vent Damaged	Repair
Engine Management Lights Set	Repair
Headlight Left Damaged	Repair
Headlight Right Damaged	Replace
Seat Front Left Damaged	Repair
Seat Front Right Damaged	Repair
Sun Visor Left Damaged	Repair
Front Bumper Damaged	Repair
Bonnet Damaged	Repair
Front Fender Left Damaged	Repair
Front Fender Right Damaged	Repair
Rear Fender Left Damaged	Repair
Rear Fender Right Damaged	Repair
Door Front Left Damaged	Repair
Door Front Right Damaged	Repair
Door Rear Left Damaged	Repair
Door Rear Right Damaged	Repair
Boot Lid / Hatch door Damaged	Repair
Rear bumper Damaged	Repair

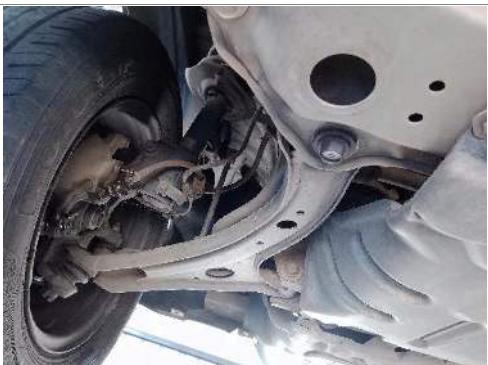
Damage	Repair Way
Sill Panel Left Damaged	Repair
Caliper 1. Axle left Leak	Replace
Caliper 1. Axle right Leak	Repair
Wheel Cylinder / Caliper 2. Axle left Leak	Replace
Service Brake Performance Rear Axle Left / Right	Repair
Difference out of legal range	
Shock Absorber Front Left Worn	Replace
Shock Absorber Front Right Worn	Replace
Control Arm Bush(es) Front Axle Left Worn	Replace
Control Arm Bush(es) Front Axle Right Worn	Replace
Tyre Front Left Damaged	Replace
Differential Oil Leak	Replace
