CONDITION REPORT

Report No: 2016218793

MFC Auction House
M57 Pretoria Rd, Glenmarais, KEMPTON PARK
Gauteng

Vehicle Type	PASSENGER VEHICLE	Registered Owner	MFC
Manufacturer	TOYOTA	Registration Number	FH975MGP
Model	AVANZA	Register Number	
VIN	MHKM5FB2N0K000317	Date Of First Licensing	
Engine Number		Last COR	
Doors	5	License Expiry Date	30/09/2020
Color	WHITE	Power / Displacement	
Year Model		Paint Finish	TWO COAT UNI
Km Reading	133,950 KM	Fuel	PETROL
Cab / Body Type	STATION WAGON	Transmission	AUTOMATIC

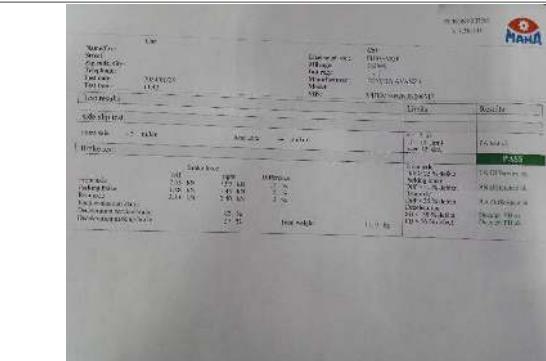
Brake test report

Left	Right	Axle Weight [KG]	Deceleration [m/s ²]
	Braking Force [kN]	Braking Force [kN]		
Front	2.33	1.93	-	
Rear	2.33	2.4	-	
Emergency / Parking	1.48	1.45	-

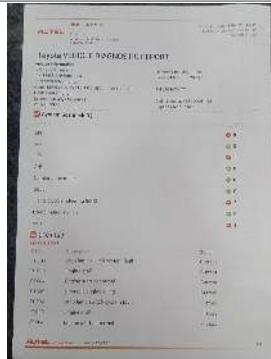
Diagnostic report page 1

No	System	Code	Description	Status
1	EFI	P0504	STOP LAMP SWITCH SYSTEM FAULT

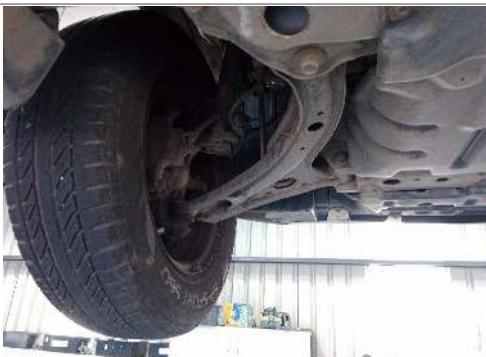
LF TYRE TREAD

Size	Load/Speed Index	Manufacture	Model	Type*	Production Date	Tread Depth (mm)
Front Left	185/70 R14	88T	Dunlop	Sp-Sport	V	4017	3 mm
Front Right	185/70 R14	88T	Dunlop	Sp-Sport	V	4017	3 mm
Rear Left	185/70 R14	88T	Dunlop	Sp-Sport	V	1317	4 mm
Rear Right	185/70 R14	88T	Dunlop	Sp-Sport	V	2017	4 mm

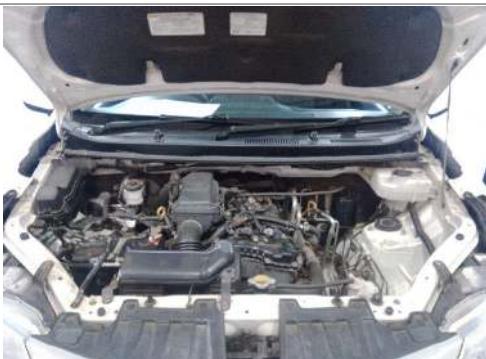
ENGINE 1

Damage	Repair Way
Engine Wiring Defective	Repair
Windscreen Wiper Damaged	Replace
Headlight Left Defective	Repair
Headlight Right Defective	Repair
Seat Front Left Dirty	Repair
Seat Front Right Damaged	Repair
Seat Rear Damaged	Repair
Seat Rear (2. Row) Damaged	Repair
Hood Lining Damaged	Repair
Door Panel Rear Right Defective	Repair
Boot Panel Left Defective	Repair
Boot Panel Right Defective	Repair
Steering Wheel Trim Defective	Repair
Front Bumper Paintwork • Scratched	Repair
Grill Paintwork • Scratched	Repair
Bonnet Paintwork • Scratched	Repair
B • Pillar Right Dented	Repair
C • Pillar Right Dented	Repair
Front Fender Left Paintwork • Scratched	Repair
Front Fender Right Paintwork • Scratched	Repair
Rear Fender Left Dented	Repair
Rear Fender Right Dented	Repair
Rear Fender Left / Inner Tray Dented	Repair
Rear Fender Right / Inner Tray Dented	Repair
Door Front Left Paintwork • Scratched	Repair
Door Front Right Dented	Repair

General Comments: ACCORDING TO AGE AND MILEAGE OF VEHICLE NORMAL WEAR AND TEAR ON INTERIOR, EXTERIOR, ELECTRICAL AND MECHANICAL PARTS.SHOCK ABSORBER TEST COULD NOT BE PERFORMED.Engine Compartment: Engine bay dirty.Brake fluid level ok.Corrosion on battery box.
 Li
