MFC Auction House
M57 Pretoria Rd, Glenmarais, KEMPTON PARK
Gauteng

DEKRA MFC
M57 Pretoria Rd - 1619
KEMPTON PARK - GT
08610 33572

VEHICLE INSPECTION

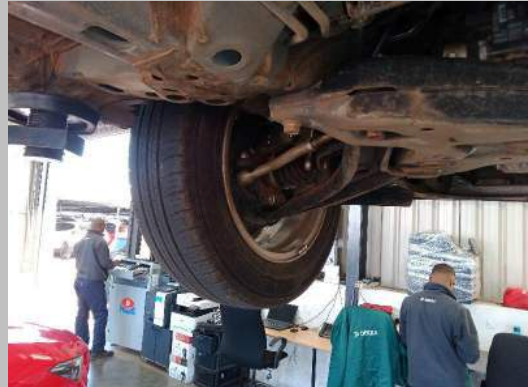
LF TYRE TREAD

Size	Load/Speed Index	Manufacture	Model	Type*	Production Date	Tread Depth (mm)
Front Left	195/65R16	92H	Dunlop	Enasave	V	1523	4 mm
Front Right	195/65R16	92H	Dunlop	Enasave	V	1523	4 mm
Rear Left	195/65R16	92H	Dunlop	Enasave	V	1523	4 mm
Rear Right	195/65R16	92H	Dunlop	Enasave	V	1523	4 mm
Spare	195/65R16	92H	Dunlop	Enasave	V	0000	4 mm
