**CONDITION REPORT**

Report No: 2016875409

**DATE**  
13/05/2025

Vehicle Type	PASSENGER VEHICLE	Registered Owner	
Manufacturer	MAZDA	Registration Number	KBS225EC
Model	MAZDA2 1.5 DYNAMIC 5-DR [2015-2017]	Register Number	
VIN	MM6DJ2HA6FW109337	Date Of First Licensing	
Engine Number		Last COR	
Doors	5	License Expiry Date	30/09/2023
Color	SILVER	Power / Displacement	
Year Model	2015	Paint Finish	M - METALLIC
Km Reading	150,541 KM	Fuel	PETROL
Cab / Body Type	HATCHBACK	Transmission	MANUAL

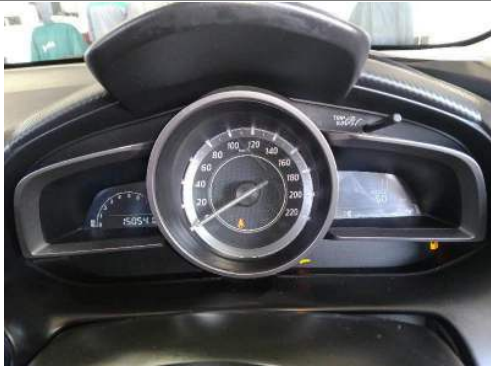
DASHBOARD (W/ ENGINE RUNNING)

No	System	Code	Description	Status
1	CMDTCS	U3003:16-08	BATTERY VOLTAGE

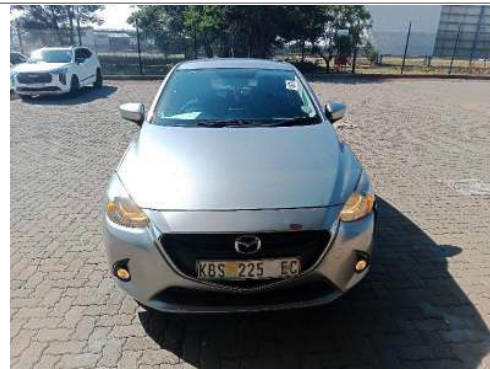
90 DEGREE FRONT

Damage	Repair Way
Side Mirror Left Paintwork • Scratched	Repair
Side Mirror Right Paintwork • Scratched	Repair
Front Bumper Damaged	Repair
Front Fender Left Dented	Repair
Front Fender Right Dented	Repair
Rear Fender Left Dented	Repair
Door Front Left Dented	Repair
Door Front Right Dented	Repair
Door Rear Left Dented	Repair
Door Rear Right Paintwork • Scratched	Repair
Boot Lid / Hatch door Dented	Repair
Rear bumper Paintwork • Scratched	Repair
Service Brake Performance Front Axle Left / Right	Repair
Difference out of legal range

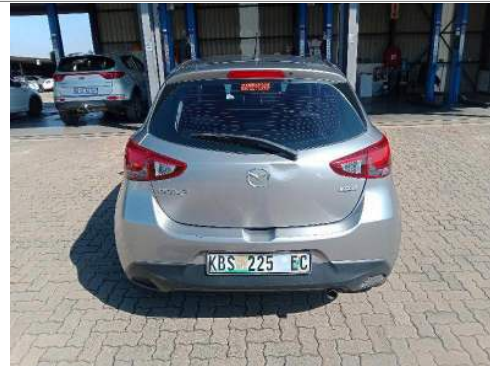
90 DEGREE REAR

General Comments: ACCORDING TO THE AGE AND MILEAGE OF THE VEHICLE, NORMAL WEAR AND TEAR MARKS ARE VISIBLE ON THE INTERIOR, EXTERIOR, ELECTRICAL AND MECHANICAL PARTS. Body • Exterior: Vehicle got some scratches, stone chips and dents.
