MFC Auction House  
M57 Pretoria Rd, Glenmarais, KEMPTON PARK  
Gauteng

| Manufacturer | TOYOTA | Registration Number | FYK681L |

## CONDITION REPORT

Report No: 2016348420

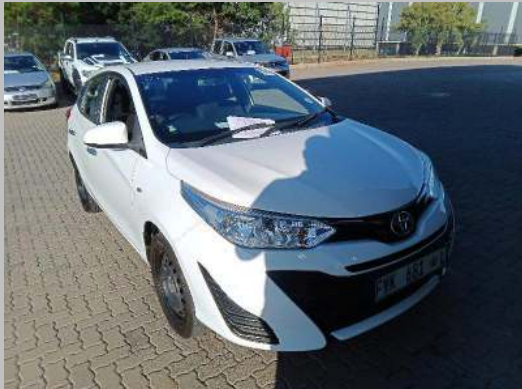
FRONT RIGHT CORNER

| Damage | Repair Way |
|---|---|
| Front Bumper Damaged | Repair |
| Tyre Front Right Worn | Replace |

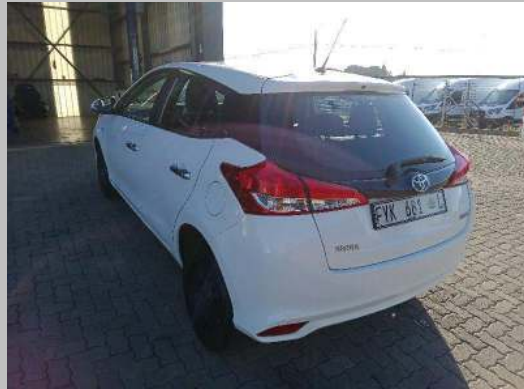
REAR LEFT CORNER

| Damage | Repair Way |
|---|---|
| Rear bumper Damaged | Repair |

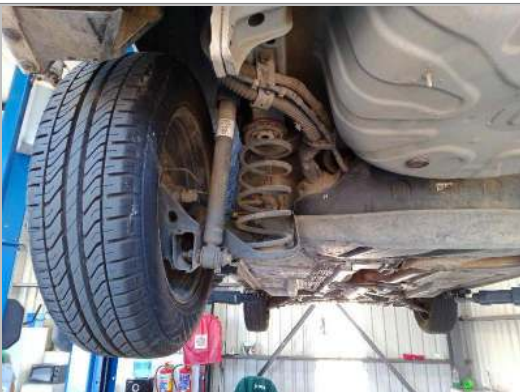
LR TYRE TREAD

| | Size | Load/Speed Index | Manufacture | Model | Type* | Production Date | Tread Depth (mm) |
|---|---|---|---|---|---|---|---|
| Rear Left | 185/65R15 | 95H | Dunlop | Sp | V | 0623 | 4 mm |

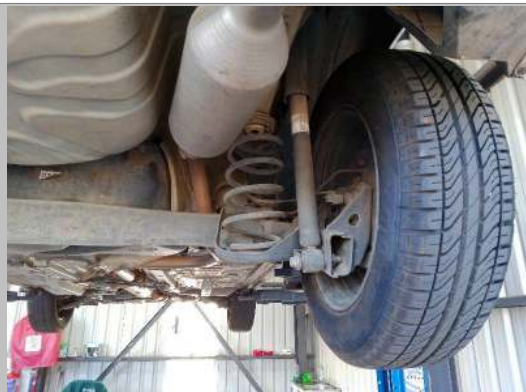
RR TYRE TREAD

| | Size | Load/Speed Index | Manufacture | Model | Type* | Production Date | Tread Depth (mm) |
|---|---|---|---|---|---|---|---|
| Rear Right | 185/65R15 | 92H | Dunlop | Sp | V | 0623 | 4 mm |
