CONDITION REPORT

Report No: 2016276249

MFC Auction House
M57 Pretoria Rd, Glenmarais, KEMPTON PARK
Gauteng

Vehicle Type	LIGHT LOAD VEHICLE	Registered Owner	MFC AUCTION HOUSE
Manufacturer	HONDA	Registration Number	HDH719MP
Model	CR-V	Register Number	
VIN	MRHRM1750EP000027	Date Of First Licensing	
Engine Number		Last COR	
Doors	5	License Expiry Date	31/08/2021
Color	BROWN	Power / Displacement	
Year Model		Paint Finish	TWO COAT METALLIC
Km Reading	43,303 KM	Fuel	PETROL
Cab / Body Type	STATION WAGON	Transmission	MANUAL

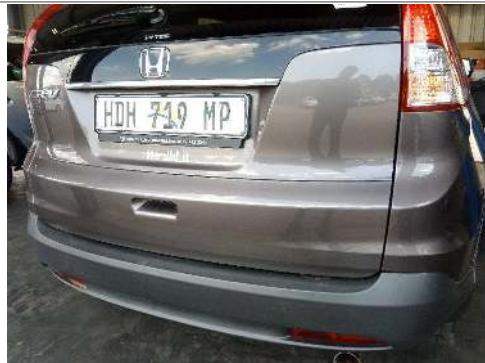
Damage	Repair Way
Headlight Left Scratched	Repair
Side Mirror Left Paintwork • Scratched	Repair
Front Bumper Paintwork • Scratched	Repair
Grill Paintwork • Scratched	Repair
Bonnet Paintwork • Scratched	Repair
Front Fender Left Paintwork • Scratched	Repair
Rear Fender Right Paintwork • Scratched	Repair
Door Front Left Paintwork • Scratched	Repair
Door Front Right Paintwork • Scratched	Repair
Door Rear Left Paintwork • Scratched	Repair
Door Rear Right Paintwork • Scratched	Repair
Rear bumper Paintwork • Scratched	Repair
Engine to silencer pipe Welded	Replace
Steering Malfunction	Repair
Body and Exterior	Dents and scratches on some body panels.
Body and Exterior	Some body panels misaligned
Body and Exterior	Spray work and stone chips on some body panels.
Undercarriage	Vehicle undercarriage dirty
Tyres and Rims	Alloy rims scratched.
Engine	Engine bay dirty. Brake fluid level ok.
Electrical components and Instruments	Vehicle electronics malfunctioning
