MFC Auction House
M57 Pretoria Rd, Glenmarais, KEMPTON PARK
Gauteng

Vehicle Type	PASSENGER VEHICLE	Registered Owner	MFC AUCTION HOUSE
Manufacturer	KIA	Registration Number	JV51KSGP
Model	SELTOS	Register Number	
VIN	MZBER814MMN160539	Date Of First Licensing	
Engine Number		Last COR	
Doors	5	License Expiry Date	
Color	BLUE	Power / Displacement	
Year Model		Paint Finish	M - METALLIC
Km Reading	114,863 KM	Fuel	PETROL
Cab / Body Type	HATCHBACK	Transmission	AUTOMATIC

VEHICLE INSPECTION

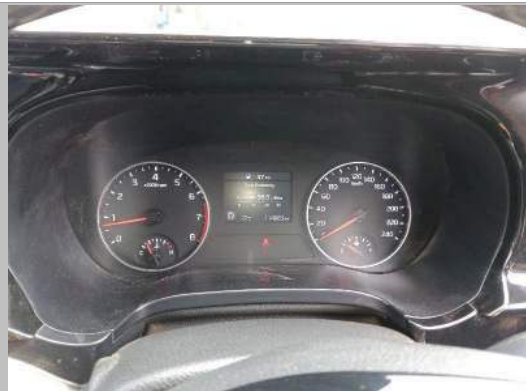
DASHBOARD (W/ ENGINE RUNNING)

No	System	Code	Description	Status
1	HISTORY	B2617:00	CLUSTER AIRBAG WARNING LAMP CAN MESSAGE TIME OUT

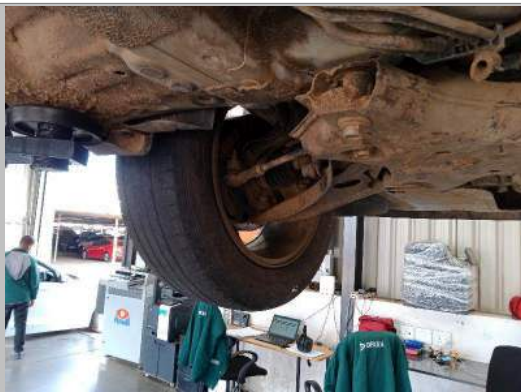
LF TYRE TREAD

Size	Load/Speed Index	Manufacture	Model	Type*	Production Date	Tread Depth (mm)
Front Left	215/60R17	96H	Goodyear	Assurance	V	3721	3 mm
Front Right	215/60R17	96H	Goodyear	Assurance	V	3720	3 mm
Rear Left	215/60R17	96H	Dunlop	Sp sport	V	1221	2 mm
Rear Right	215/60R17	96H	Bridgestone	Turanza	V	4215	3 mm
Spare	215/60R17	96H	Goodyear	Assurance	V	3620	0 mm

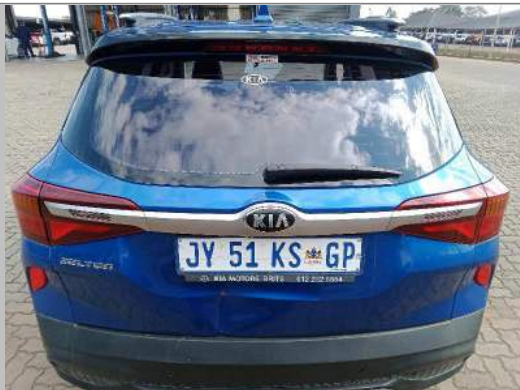
Damage	Repair Way
Parcel Tray Missing	Repair
Front Bumper Paintwork • Scratched	Repair
Front Fender Left Paintwork • Scratched	Repair
Front Fender Right Paintwork • Scratched	Repair
Rear Fender Left Dented	Repair
Rear Fender Right Dented	Repair
Door Front Left Paintwork • Chipmarks	Repair
Door Rear Left Paintwork • Scratched	Repair
Door Rear Right Paintwork • Scratched	Repair
Boot Lid / Hatch door Dented	Repair
Rear bumper Paintwork • Scratched	Repair
Windscreen Cracked	Replace
Spare Tyre Excessive Wear & Tear	Replace
License disc missing	Replace
