## CONDITION REPORT

Report No:  
2017297100  
DATE  
10/09/2026

MFC Auction House  
M57 Pretoria Rd, Glenmarais, KEMPTON PARK  
Gauteng

| Manufacturer | KIA | Registration Number | LC02TZGP |

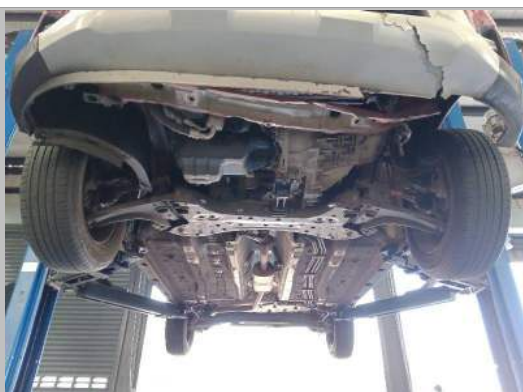
Front chassis

| Damage | Repair Way |
|---|---|
| Sub Frame Damaged | Replace |
| Radiator Cradle Damaged | Replace |

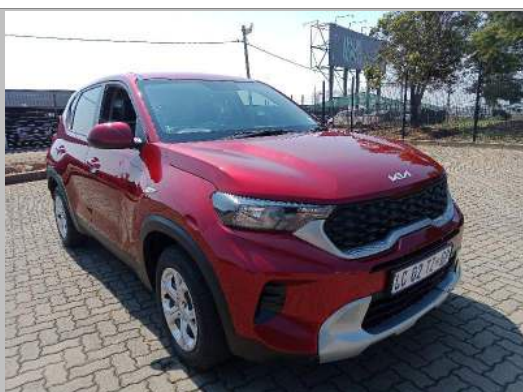
FRONT RIGHT CORNER

Body • Exterior: Dents and scratches on body panels. Signs of impact damage to the front of the vehicle. Body panels misaligned.

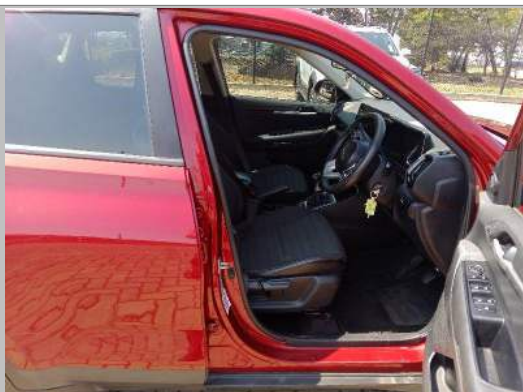
INTERIOR (FRONT DRIVER DOOR)

| Damage | Repair Way |
|---|---|
| Door Panel Front Right Defective | Repair |

Interior: The vehicle interior is dirty, and the panels are scratched. Front right door panel loose.

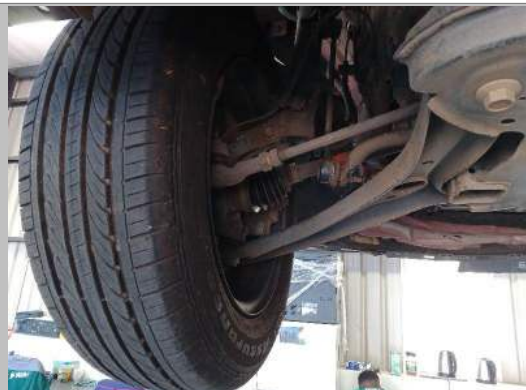
LF TYRE TREAD

| | Size | Load/Speed Index | Manufacture | Model | Type* | Production Date | Tread Depth (mm) |
|---|---|---|---|---|---|---|---|
| Front Left | 195/65R15 | 91H | Goodyear | Assurance | V | 3822 | 3 mm |

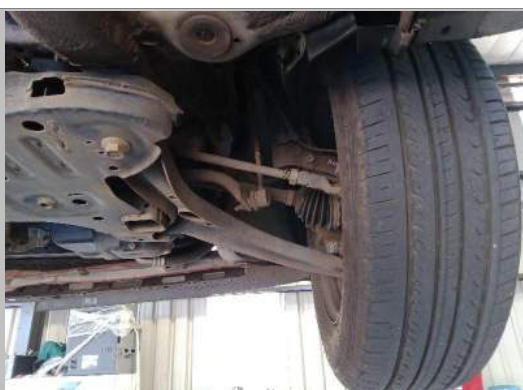
RF TYRE TREAD

| | Size | Load/Speed Index | Manufacture | Model | Type* | Production Date | Tread Depth (mm) |
|---|---|---|---|---|---|---|---|
| Front Right | 195/65R15 | 91H | Goodyear | Assurance | V | 2522 | 3 mm |

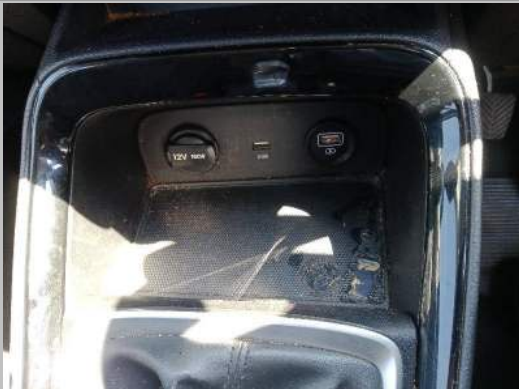
| Damage | Repair Way |
|---|---|
| Center Console / Cubbyhole + Lid Defective | Repair |

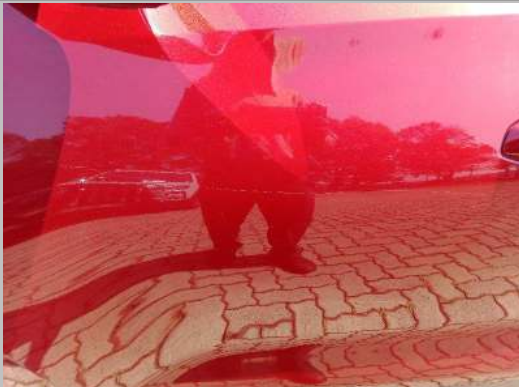
| Damage | Repair Way |
|---|---|
| Door Front Left Paintwork • Scratched | Repair |

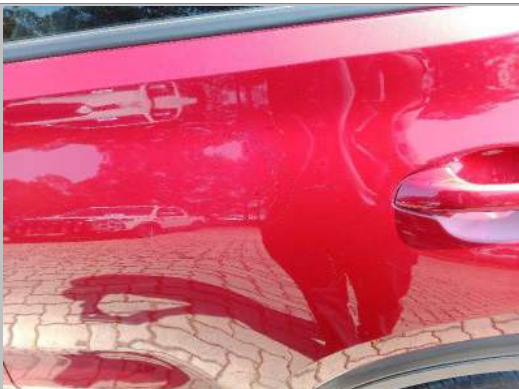
| Damage | Repair Way |
|---|---|
| Door Sealing Rubber Rear Left Damaged | Replace |
| Door Rear Left Paintwork • Scratched | Repair |

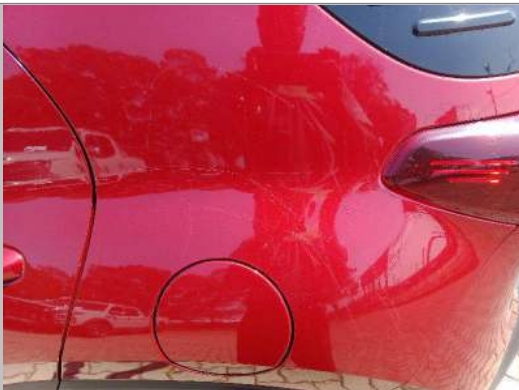
| Damage | Repair Way |
|---|---|
| Rear Fender Left Paintwork • Scratched | Repair |
