## CONDITION REPORT

Report No:  
2017299879  
DATE  
16/09/2026

MFC Auction House  
M57 Pretoria Rd, Glenmarais, KEMPTON PARK  
Gauteng

| Manufacturer | KIA | Registration Number | LM80LLGP |

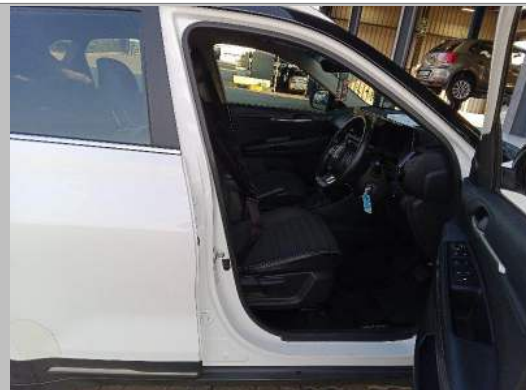
INTERIOR (FRONT DRIVER DOOR)

Interior: Vehicle interior dirty and panels scratched.

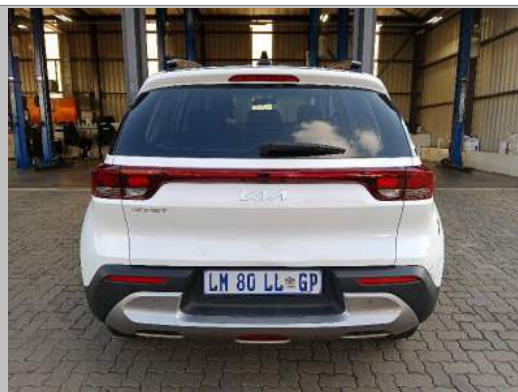
90 DEGREE REAR

| Damage | Repair Way |
|---|---|
| Rear bumper Damaged | Repair |

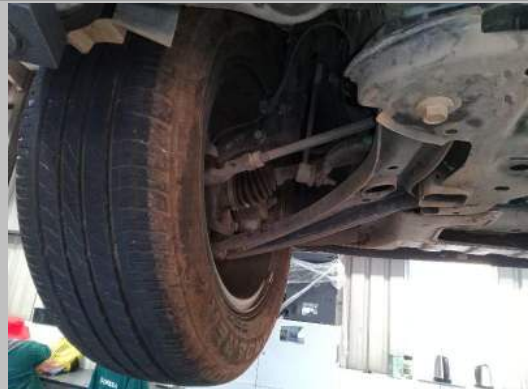
LF TYRE TREAD

| | Size | Load/Speed Index | Manufacture | Model | Type* | Production Date | Tread Depth (mm) |
|---|---|---|---|---|---|---|---|
| Front Left | 215/60 R16 | 95H | MRF | Wanderer | V | 2523 | 4 mm |

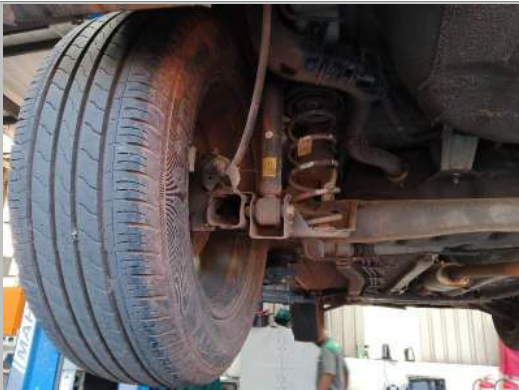
LR TYRE TREAD

| | Size | Load/Speed Index | Manufacture | Model | Type* | Production Date | Tread Depth (mm) |
|---|---|---|---|---|---|---|---|
| Rear Left | 215/60 R16 | 95H | MRF | Wanderer | V | 2523 | 4 mm |

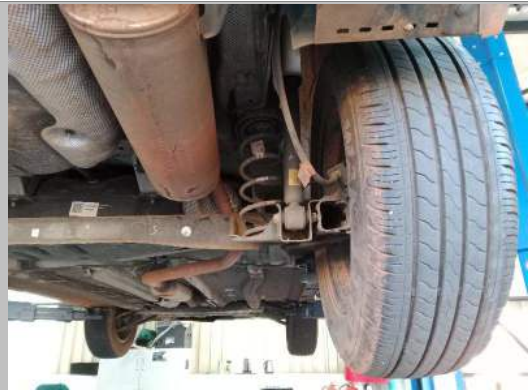
RR TYRE TREAD

| Damage | Repair Way |
|---|---|
| Tyre Rear Right Damaged | Replace |

| | Size | Load/Speed Index | Manufacture | Model | Type* | Production Date | Tread Depth (mm) |
|---|---|---|---|---|---|---|---|
| Rear Right | 215/60 R16 | 95H | MRF | Wanderer | V | 2523 | 5 mm |

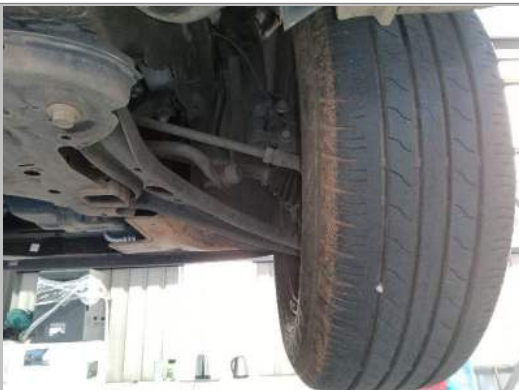
RF TYRE TREAD

| | Size | Load/Speed Index | Manufacture | Model | Type* | Production Date | Tread Depth (mm) |
|---|---|---|---|---|---|---|---|
| Front Right | 215/60 R16 | 95H | MRF | Wanderer | V | 2423 | 4 mm |

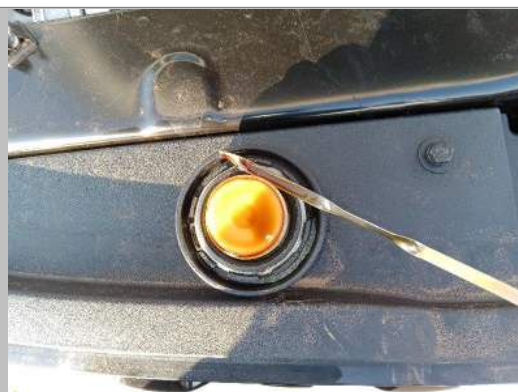
Oil cap and dipstick

| Damage | Repair Way |
|---|---|
| Engine Oil Sweat | Repair |
