## CONDITION REPORT

Report No:  
2017302331  
DATE  
22/09/2026

| Manufacturer | LAND ROVER | Registration Number | KH07JCGP |
| Model | RANGE ROVER EVOQUE 2.2 SD4 DSL<br>DYNAMIC 4WD AT [2011-2013] | Register Number | |

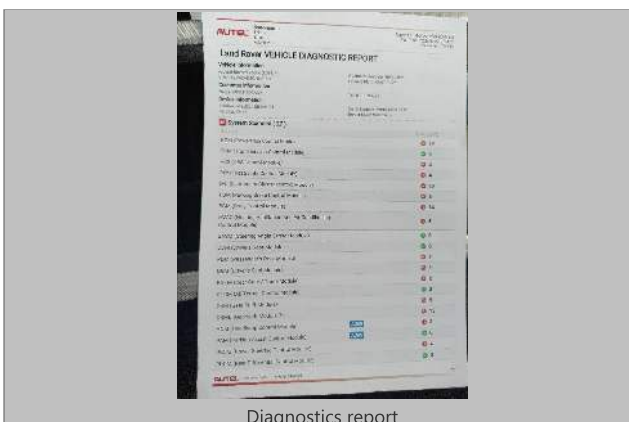
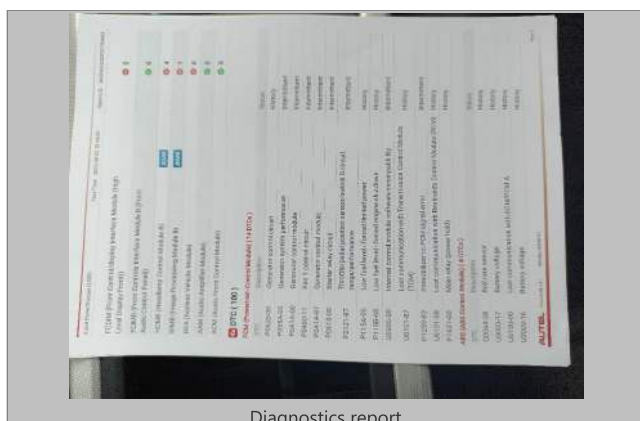
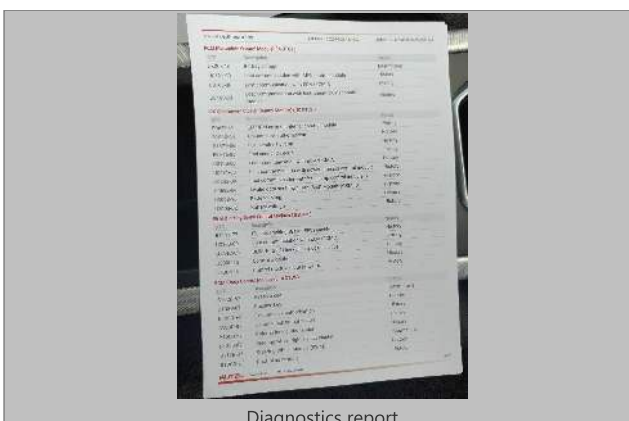
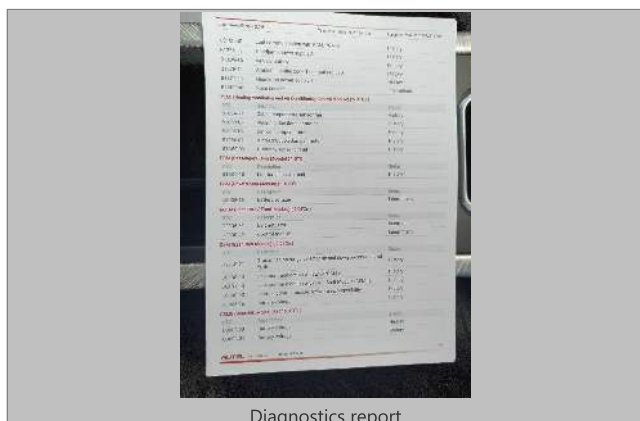
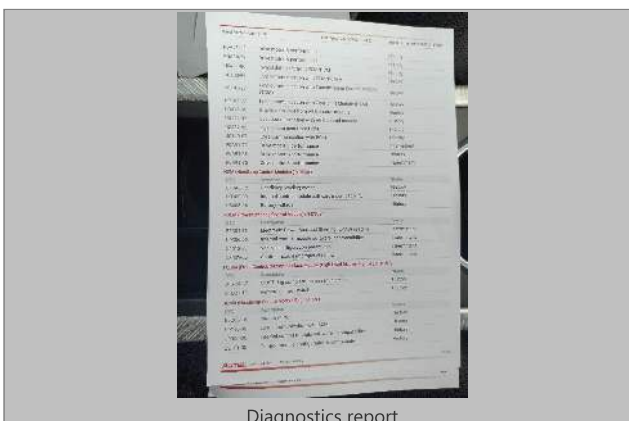
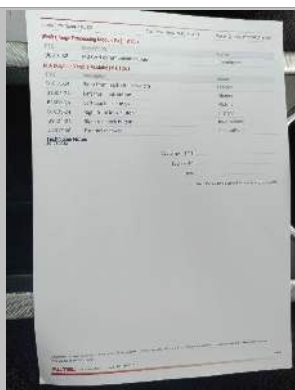
Diagnostics report

During the diagnostic the following error messages were detected: (See also attached Diagnostic Report. For more information regarding the Fault Codes (DTC) and the recommended rectifications please contact the workshops of the vehicle manufacture).

| No | System | Code | Description | Status |
|---|---|---|---|---|
| 1 | POWERTRAC CONTROL MODULE | P0620-00 | GENERATOR CONTROL CIRCUIT | |

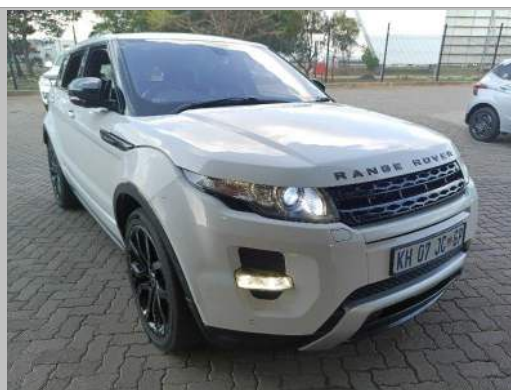
FRONT RIGHT CORNER

| Damage | Repair Way |
|---|---|
| Front Fender Right Paintwork • Scratched | Repair |

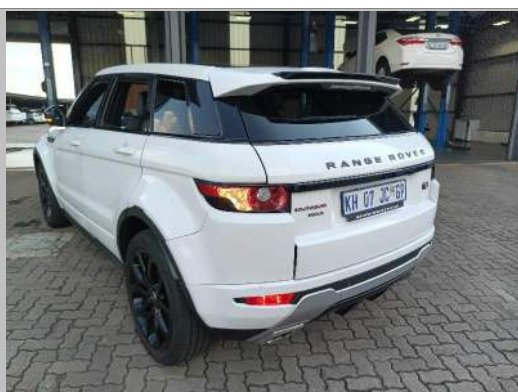
REAR LEFT CORNER

| Damage | Repair Way |
|---|---|
| Rear Fender Left Paintwork • Scratched | Repair |

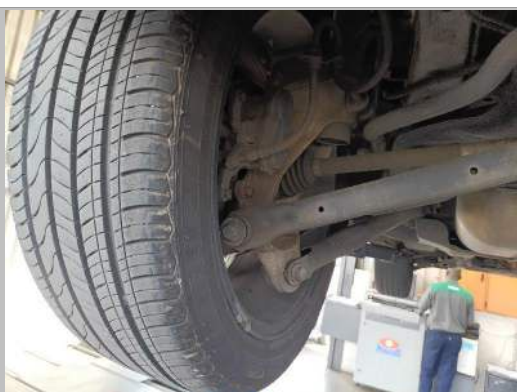
LR TYRE TREAD

| | Size | Load/Speed Index | Manufacture | Model | Type* | Production Date | Tread Depth (mm) |
|---|---|---|---|---|---|---|---|
| Rear Left | 245/45R20 | 103Y | Anchee | AC | V | 4023 | 6 mm |

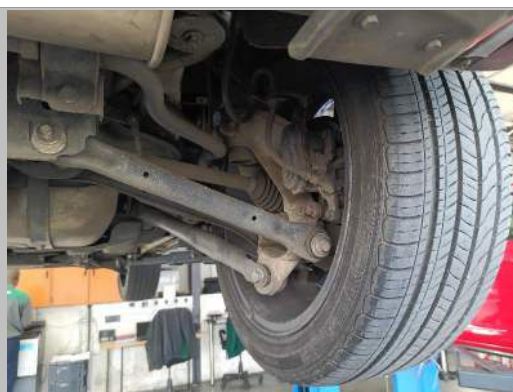
RR TYRE TREAD

| | Size | Load/Speed Index | Manufacture | Model | Type* | Production Date | Tread Depth (mm) |
|---|---|---|---|---|---|---|---|
| Rear Right | 245/45R20 | 103Y | Anchee | AC | V | 4023 | 6 mm |

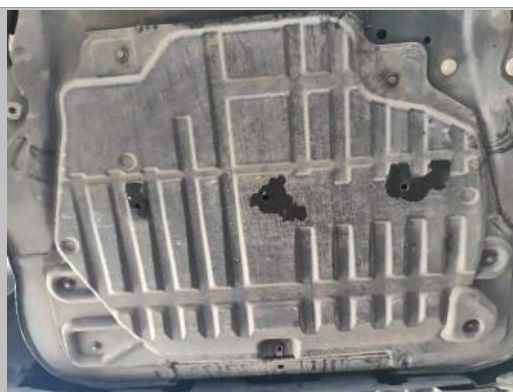
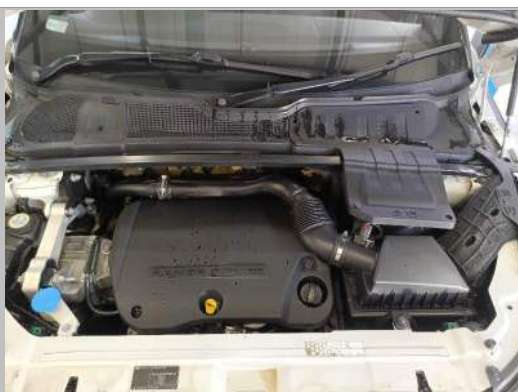
ENGINE 1

| Damage | Repair Way |
|---|---|
| Engine Oil Sweat | Repair |
