MFC Auction House
M57 Pretoria Rd, Glenmarais, KEMPTON PARK
Gauteng

DEKRA MFC
M57 Pretoria Rd - 1619
KEMPTON PARK - GT
08610 33572

VEHICLE INSPECTION

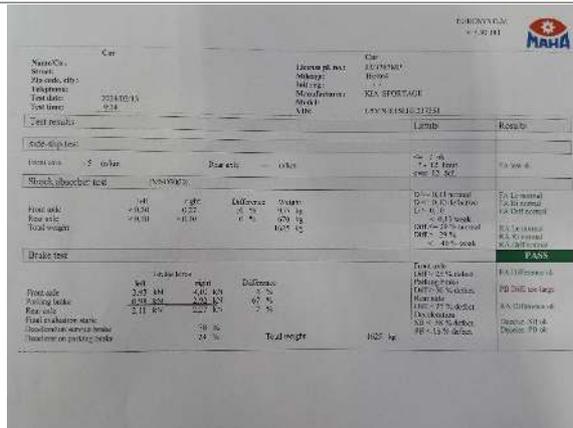
BRAKE AND SHOCK REPORT

Left	Right	Axle Weight [KG]	Deceleration [m/s ²]
	Braking Force [KN]	Braking Force [KN]		
Front	3.93	4.1	-	
Rear	2.11	2.27	-	
Emergency / Parking	0.98	2.92	-

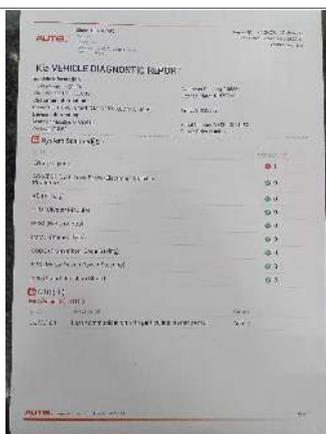
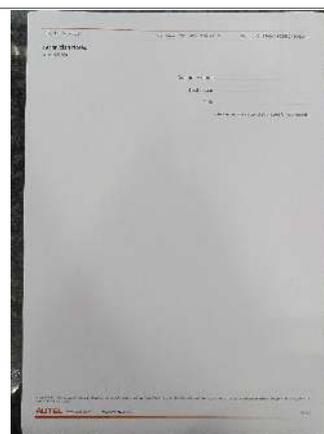
No	System	Code	Description	Status
1	ENG(ENGINE)	U02A3:00	LOST COMMUNICATION WITH PARTICULATE MATTER SENSOR

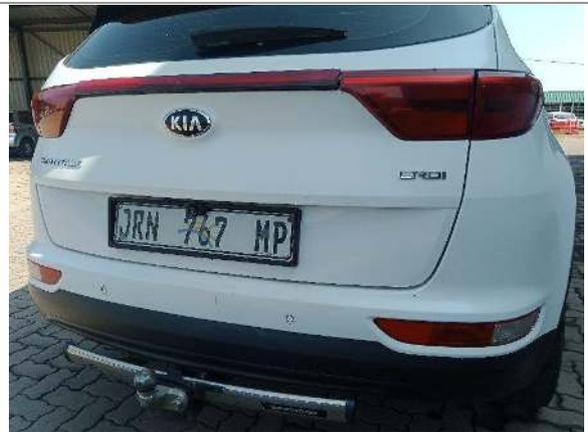
Door Rear Left Paintwork • Scratched	Repair
Door Rear Right Paintwork • Scratched	Repair
Boot Lid / Hatch door Paintwork • Scratched	Repair
Rear bumper Paintwork • Scratched	Repair
Sill Panel Left Defective	Repair

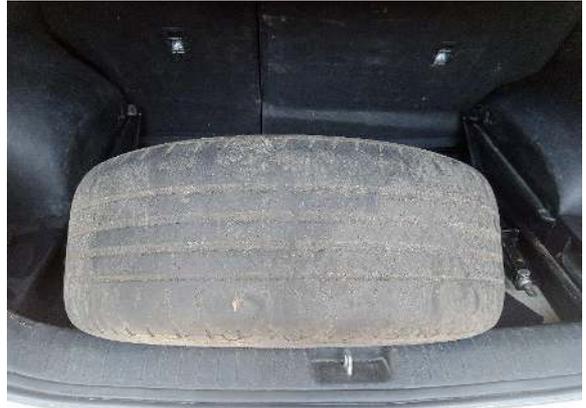
Spare Tyre

Size	Load/Speed Index	Manufacture	Model	Type*	Production Date	Tread Depth (mm)
Front Left	225/55 R18	102W	Blackhawk	Radial	V	1523	5 mm
Front Right	225/55 R18	98V	Fortune	All Season	V	1823	3 mm
Rear Left	225/55 R18	98V	Fortune	All Season	V	1823	3 mm
Rear Right	225/55 R18	98H	Lanvigator	Performax	V	1621	1 mm
Spare	225/60 R17	99V	Voyager	Radial	V	4419	0 mm
