CONDITION REPORT

Report No: 2016887184

MFC Auction House  
M57 Pretoria Rd, Glenmarais, KEMPTON PARK  
Gauteng

| Manufacturer | RENAULT | Registration Number | JF99NHGP |

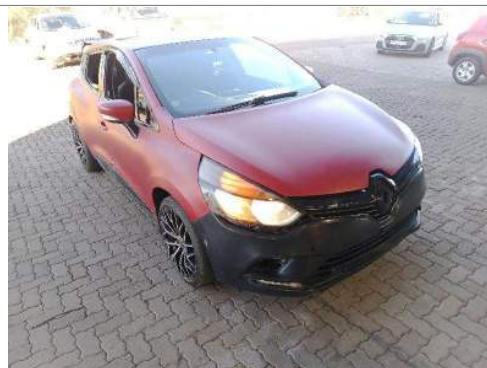
FRONT RIGHT CORNER

| Damage | Repair Way |
|---|---|
| Headlight Right Damaged | Repair |

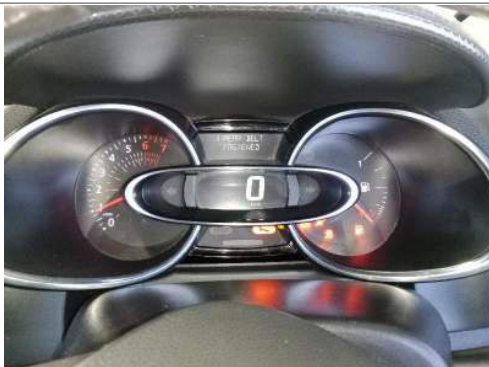
DASHBOARD (W/ ENGINE RUNNING)

| Damage | Repair Way |
|---|---|
| Engine management lights illuminated | Repair |

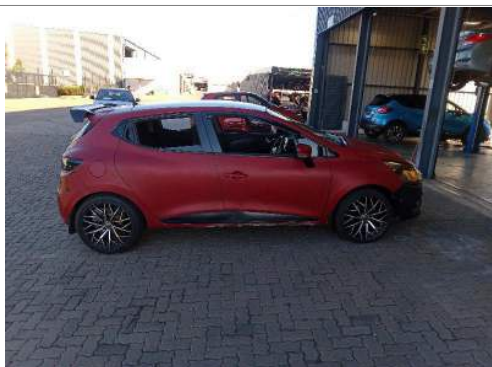
90 DEGREE RIGHT

| Damage | Repair Way |
|---|---|
| Door Front Right Dented | Repair |

| Damage | Repair Way |
|---|---|
| Sill Panel Right Dented | Repair |

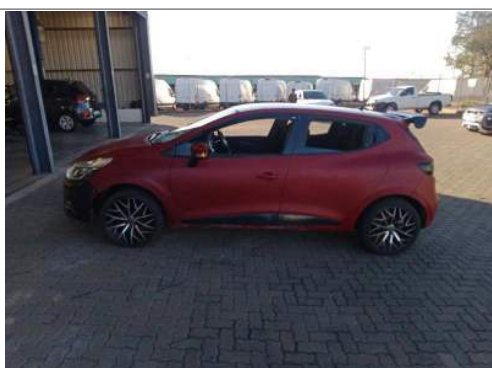
90 DEGREE LEFT

| Damage | Repair Way |
|---|---|
| Sill Panel Left Dented | Repair |

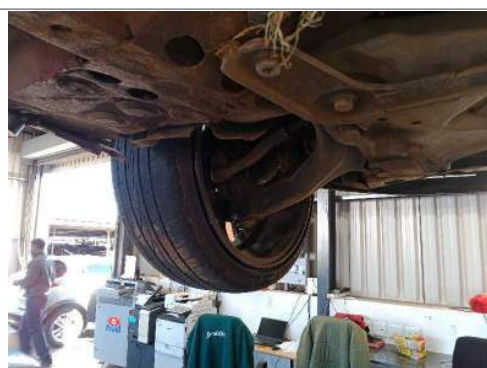
LF TYRE TREAD

| Damage | Repair Way |
|---|---|
| Tyre Front Left Torn / Cut | Repair |

| | Size | Load/Speed Index | Manufacture | Model | Type* | Production Date | Tread Depth (mm) |
|---|---|---|---|---|---|---|---|
| Front Left | 205/40R17 | 84W | Sumitomo | Bc100 | V | 2321 | 3 mm |

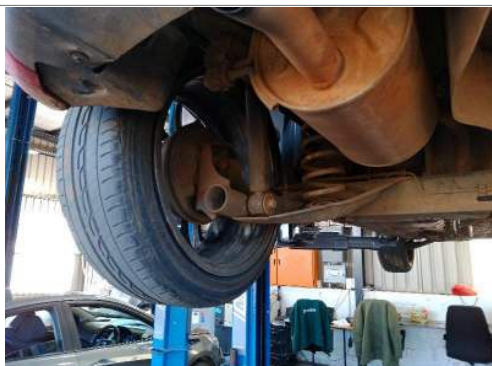
LR TYRE TREAD

| Damage | Repair Way |
|---|---|
| Tyre Rear Left Damaged | Replace |
| Rear tyres size differs | Replace |

| | Size | Load/Speed Index | Manufacture | Model | Type* | Production Date | Tread Depth (mm) |
|---|---|---|---|---|---|---|---|
| Rear Left | 205/45R17 | 88V | Michelin | Primacy | V | 0315 | 2 mm |

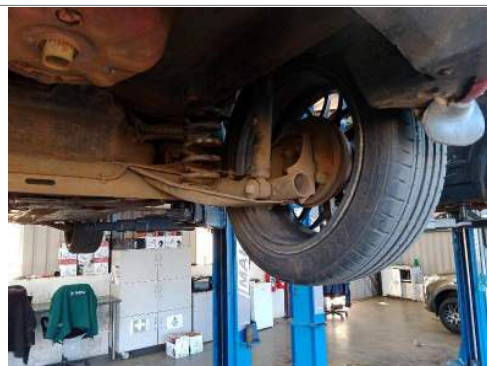
RR TYRE TREAD

| Damage | Repair Way |
|---|---|
| Tyre Rear Right Defective | Repair |

| | Size | Load/Speed Index | Manufacture | Model | Type* | Production Date | Tread Depth (mm) |
|---|---|---|---|---|---|---|---|
| Rear Right | 205/50R17 | 93W | Atlas | Sport green | V | 0418 | 3 mm |

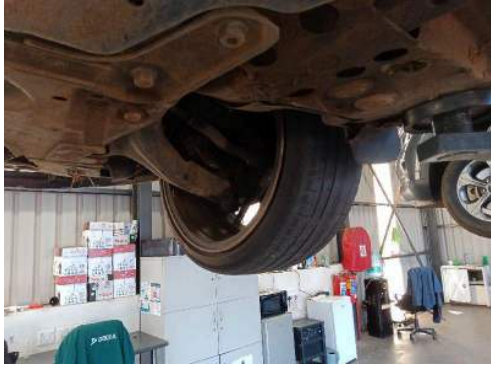
RF TYRE TREAD

| Damage | Repair Way |
|---|---|
| Tyre Front Right Smooth | Replace |

| | Size | Load/Speed Index | Manufacture | Model | Type* | Production Date | Tread Depth (mm) |
|---|---|---|---|---|---|---|---|
| Front Right | 205/40R17 | 84W | Velocity | Speed max | V | 4519 | 0 mm |
