CONDITION REPORT

Report No: 2016206362

DATE
19/12/2023

Vehicle Type	PASSENGER VEHICLE	Registered Owner	MFC
Manufacturer	RENAULT	Registration Number	FT51GNGP
Model	SANDERO	Register Number	
VIN	VF15SRAAC56415418	Date Of First Licensing	
Engine Number		Last COR	
Doors	5	License Expiry Date	30/11/2023
Color	SILVER	Power / Displacement	
Year Model		Paint Finish	M - METALLIC
Km Reading	115,645 KM	Fuel	PETROL
Cab / Body Type	HATCHBACK	Transmission	MANUAL

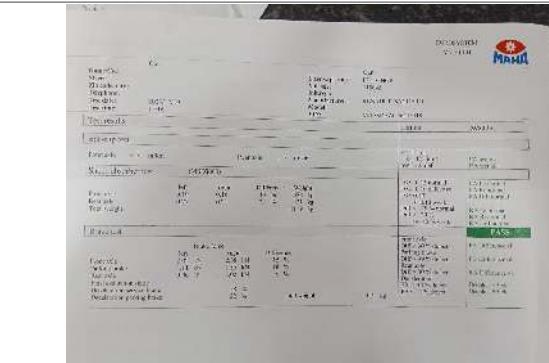
Shock and brake report

Left	Right		
	Braking Force [kN]	Braking Force [kN]	Axle Weight [kg]	Deceleration [m/s ²]
Front	2.0	2.3	-	
Rear	0.9	1.0	-	
Emergency / Parking	1.1	1.3	-

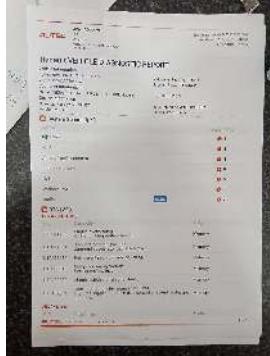
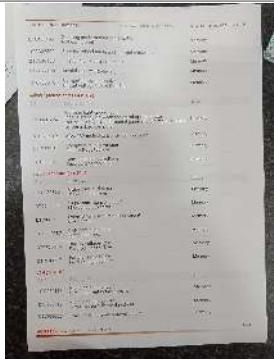
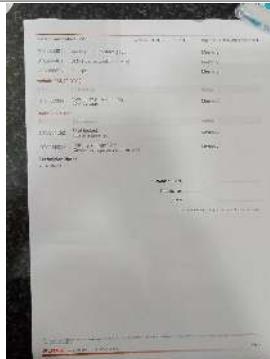
Diagnostic test

During the diagnostic no active error messages were detected. (See also attached Diagnostic Report. For more information regarding the Fault Codes (DTC) and the recommended rectifications please contact the workshops of the vehicle manufacturer).

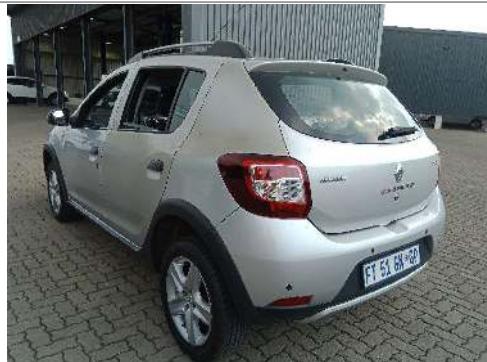
REAR LEFT CORNER

Damage	Repair Way
Fog Light Rear Left Defective	Repair
Rear Fender Left Paintwork • Dull	Repair
Door Rear Left Paintwork • Dull	Repair
Windscreen Chipped	Replace
Rim Rear Left Dented	Repair
Bolt(s) / Nut(s) Front Wheel Left Missing	Replace

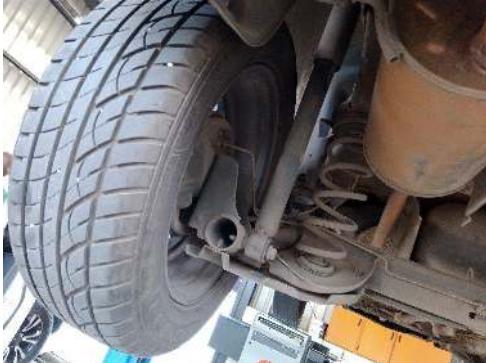
LR TYRE TREAD

Size	Load/Speed Index	Manufacture	Model	Type*	Production Date	Tread Depth (mm)
Front Left	205/55R16	91H	Continental	Contact	V	3816	1 mm
Front Right	205/55R16	91H	Continental	Contact	V	4016	5 mm
Rear Left	205/55R16	91W	Rovelo	RPX	V	0321	5 mm
Rear Right	205/55R16	91H	Continental	Contact	V	3219	5 mm
Spare	185/65R15	88T	Barum	Brilliantis	V	////	6 mm

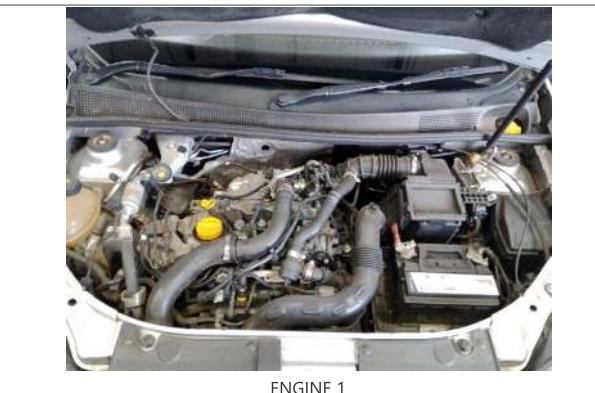
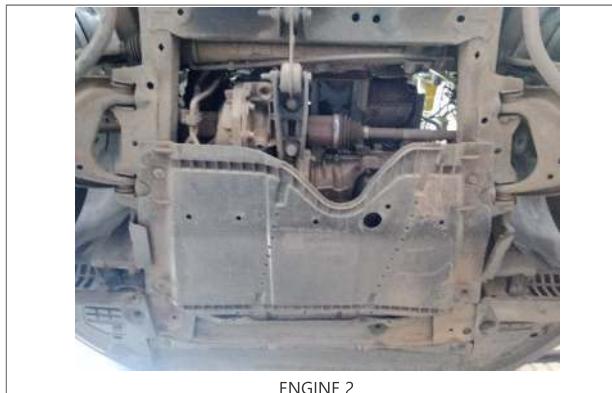
ENGINE 1

General Comments: ACCORDING TO THE AGE AND MILEAGE OF THE VEHICLE, NORMAL WEAR AND TEAR MARKS ARE VISIBLE ON THE INTERIOR, EXTERIOR, ELECTRICAL AND MECHANICAL PARTS.
 Engine Compartment: Bottom of engine is covered.
 Body • Exterior: Minor dents scratches and stone chips on some body panels. Signs of spray work done on some body panels.
