MFC Auction House
M57 Pretoria Rd, Glenmarais, KEMPTON PARK
Gauteng

Vehicle Type	PASSENGER VEHICLE	Registered Owner	
Manufacturer	RENAULT	Registration Number	FX17TCGP
Model	SANDERO	Register Number	
VIN	VF15SRAAC56972120	Date Of First Licensing	
Engine Number		Last COR	
Doors	5	License Expiry Date	
Color	WHITE	Power / Displacement	
Year Model		Paint Finish	TWO COAT UNI
Km Reading	188,820 KM	Fuel	PETROL
Cab / Body Type	HATCHBACK	Transmission	MANUAL

VEHICLE INSPECTION

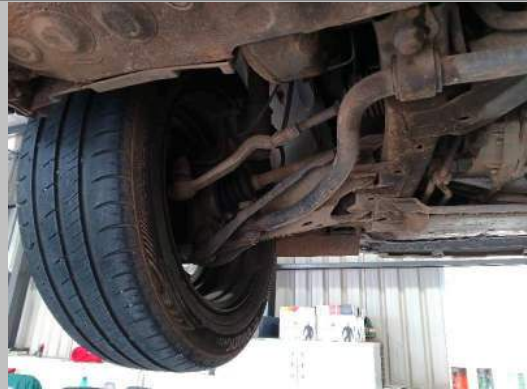
LF TYRE TREAD

Size	Load/Speed Index	Manufacture	Model	Type*	Production Date	Tread Depth (mm)
Front Left	205/55 R16	91H	Kumho	Ecowing	V	0617	3 mm
Front Right	205/55 R16	91H	Kumho	Ecowing	V	0617	2 mm
Rear Left	205/55 R16	91H	Continental	ContiEco	V	0217	2 mm
Rear Right	205/55 R16	91H	Continental	ContiEco	V	2115	2 mm
Spare	205/55 R16	91H	Continental	Contipremuim	V	2115	2 mm

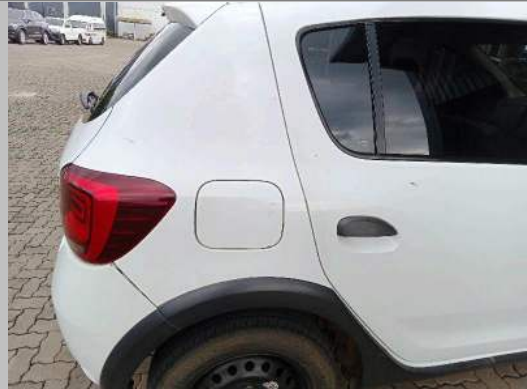
Rear Fender Right

Damage	Repair Way
Door Rear Right Paintwork • Scratched	Repair
Boot Lid / Hatch door Dented	Repair
Boot Lid / Hatch Door Rubbers Damaged	Replace
Rear bumper Damaged	Repair
Inner Boot Floor Pan and Spare Wheel Well Damaged	Repair
Sill Panel Left Paintwork • Scratched	Repair
Roof Damaged	Repair
Windscreen Cracked	Replace
Parking Brake Performance Left / Right Difference out of legal range	Repair
Brake fluid level Insufficient	Replace
Spare Tyre Damaged	Replace
Rim Front Right Dented	Repair
Rim Spare Wheel Dented	Repair
Engine	Foreign substance on oil cap
Engine	Signs of rodent in engine bay.
Warning lights illuminated on dashboard	Repair
Tyres and rims	Front left hubcap damaged
Body and Exterior	Dents and scratches on some body panels
Interior	Vehicle interior dirty and some panels scratched
Undercarriage	Bottom of engine and gearbox fully covered.
Body and Exterior	Stone chips and spray work on some body panels

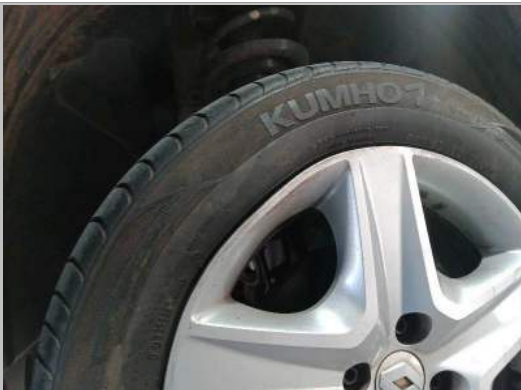
Rim Front Right

Tyres and rims	Front and rear hubcaps scratched.

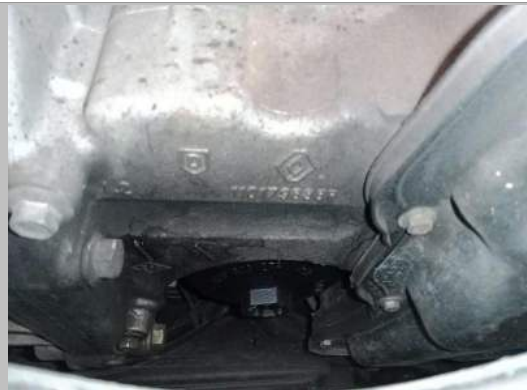
Damage	Repair Way
 	Engine Oil Leak	Repair
	Air Conditioner Insufficient	Replace
	Tail Light Left Scratched	Replace
	Seat Front Left Dirty	Repair
	Seat Front Right Damaged	Repair
	Hood Lining Dirty	Repair
	Door Sealing Rubber Front Right Damaged	Replace
	Steering Wheel Trim Defective	Repair
	Side Mirror Left Damaged	Replace
	Side Mirror Right Damaged	Replace
	Front Bumper Damaged	Repair
	Bonnet Damaged	Repair
	Front Fender Left Damaged	Repair
	Front Fender Right Paintwork • Scratched	Repair
	Rear Fender Left Paintwork • Scratched	Repair
	Rear Fender Right Paintwork • Scratched	Repair
	Rear Fender Left / Inner Tray Damaged	Repair
	Door Front Left Damaged	Repair
	Door Front Right Paintwork • Scratched	Repair
	Door Rear Left Paintwork • Scratched	Repair
