## CONDITION REPORT

Report No: 2016476675

DATE  
01/08/2024

Vehicle Type	PASSENGER VEHICLE	Registered Owner	
Manufacturer	TOYOTA	Registration Number	FH31JSGP
Model	YARIS	Register Number	
VIN	VNKKL0D340A006115	Date Of First Licensing	
Engine Number		Last COR	
Doors	5	License Expiry Date	31/05/2021
Color	BLUE	Power / Displacement	
Year Model		Paint Finish	M - METALLIC
Km Reading	161,005 KM	Fuel	PETROL
Cab / Body Type	HATCHBACK	Transmission	MANUAL

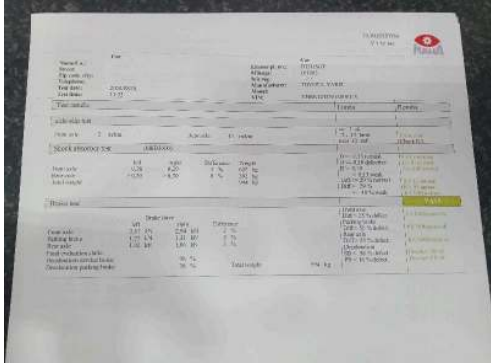
Shock and brake report

Left	Right	Axle Weight [KG]	Deceleration [m/s <sup>2</sup> ]
	Braking Force [KN]	Braking Force [KN]		
Front	2.8	2.9	-	
Rear	1.9	1.8	-	
Emergency / Parking	1.2	1.3	-

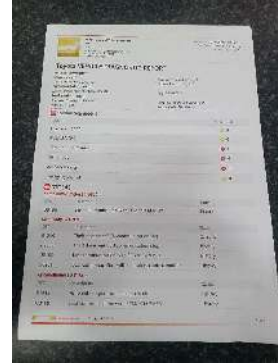
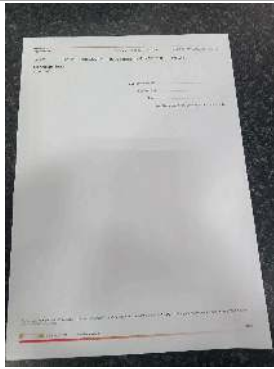
Diagnostic report

No	System	Code	Description	Status
1	CURRENT	B1269	THEFT DETERRENT ECU COMMUNICATION STOP

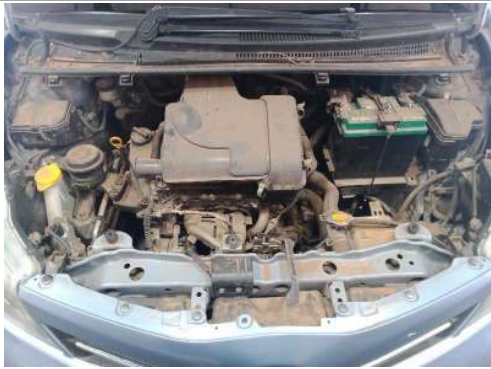
ENGINE 1

Damage	Repair Way
Engine Oil Leak	Repair
Windscreen Wiper Missing	Replace
Gear Lever Dust Boot Damaged	Repair
Front Bumper Paintwork • Overspray	Repair
Front Fender Left Paintwork • Scratched	Repair
Front Fender Right Paintwork • Pitmarks	Repair
Rear Fender Left Dented	Repair
Rear Fender Right Paintwork • Scratched	Repair
Door Front Left Dented	Repair
Door Front Right Paintwork • Pitmarks	Repair
Door Rear Left Paintwork • Scratched	Repair
Door Rear Right Paintwork • Scratched	Repair
Boot Lid / Hatch door Paintwork • Overspray	Repair
Rear bumper Paintwork • Scratched	Repair
Roof Paintwork • Pitmarks	Repair
Shock Absorber Rear Right Leak	Replace
Silencer Flange Defective	Repair
Antenna missing	Replace
