CONDITION REPORT

Report No: 2016240437

Vehicle Type	LIGHT LOAD VEHICLE	Registered Owner	MFC AUCTION HOUSE
Manufacturer	NISSAN	Registration Number	HTZ385MP
Model	NAVARA	Register Number	
VIN	VSKCVND40Z0564202	Date Of First Licensing	
Engine Number		Last COR	
Doors	4	License Expiry Date	30/09/2023
Color	WHITE	Power / Displacement	
Year Model		Paint Finish	TWO COAT UNI
Km Reading	241,942 KM	Fuel	DIESEL
Cab / Body Type	DOUBLE CAB	Transmission	AUTOMATIC

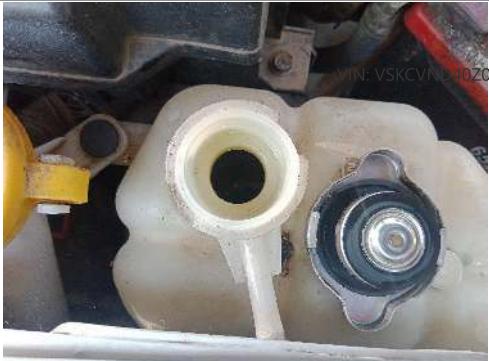
Water level

General Comments: ACCORDING TO THE AGE AND MILEAGE OF THE VEHICLE, NORMAL WEAR AND TEAR MARKS ARE VISIBLE ON THE INTERIOR, EXTERIOR, ELECTRICAL AND MECHANICAL PARTS. Engine Compartment: Engine bay dirty. Brake fluid level ok. Rust inside expansion bottle. Battery loose. Co
