MFC Auction House  
M57 Pretoria Rd, Glenmarais, KEMPTON PARK  
Gauteng

| Manufacturer | OPEL | Registration Number | JH06PHGP |

## CONDITION REPORT

Report No: 2016713971

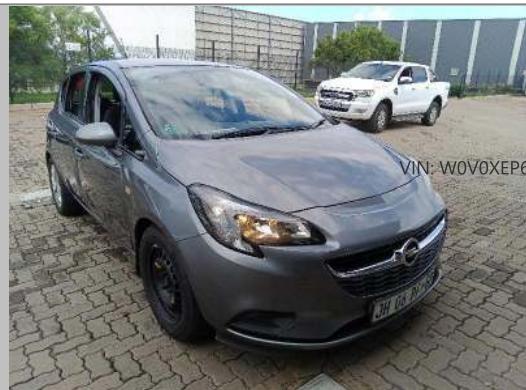
FRONT RIGHT CORNER

| Damage | Repair Way |
|---|---|
| Front Fender Right Damaged | Repair |

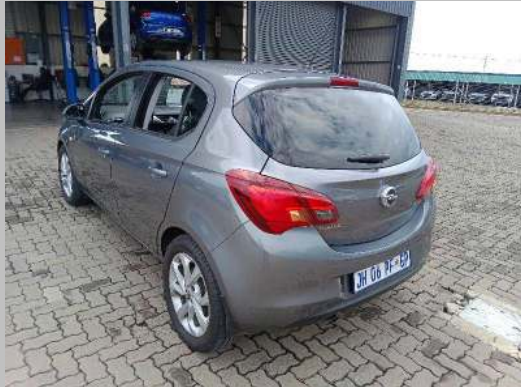
REAR LEFT CORNER

| Damage | Repair Way |
|---|---|
| Rear Fender Left Dented | Repair |

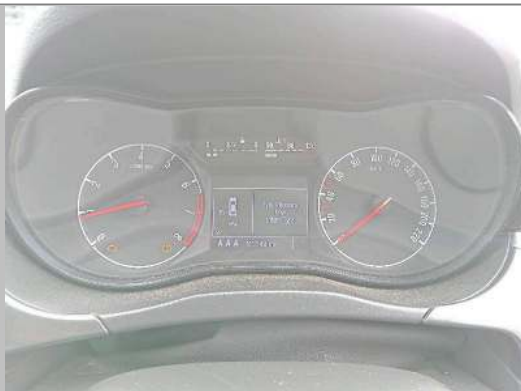
DASHBOARD (W/ ENGINE RUNNING)

| Damage | Repair Way |
|---|---|
| Warning lights illuminated | Repair |

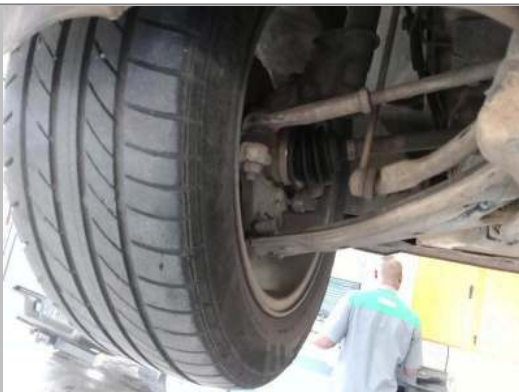
LF TYRE TREAD

| Damage | Repair Way |
|---|---|
| Front tyre size differs | Replace |

| | Size | Load/Speed Index | Manufacture | Model | Type* | Production Date | Tread Depth (mm) |
|---|---|---|---|---|---|---|---|
| Front Left | 205/55R16 | 91V | Continental | Contact | V | 0517 | 3 mm |

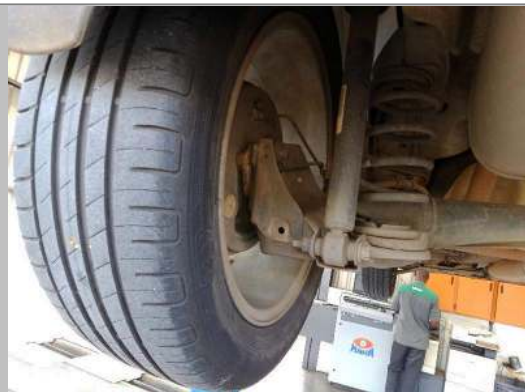
LR TYRE TREAD

| | Size | Load/Speed Index | Manufacture | Model | Type* | Production Date | Tread Depth (mm) |
|---|---|---|---|---|---|---|---|
| Rear Left | 205/55R16 | 91V | Continental | Contact | V | 2023 | 5 mm |

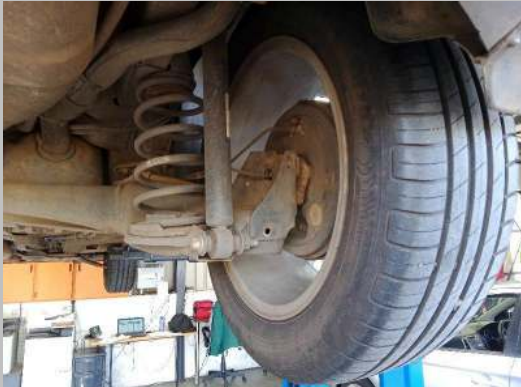
RR TYRE TREAD

| | Size | Load/Speed Index | Manufacture | Model | Type* | Production Date | Tread Depth (mm) |
|---|---|---|---|---|---|---|---|
| Rear Right | 205/55R16 | 91W | Continental | Contact | V | 1023 | 6 mm |

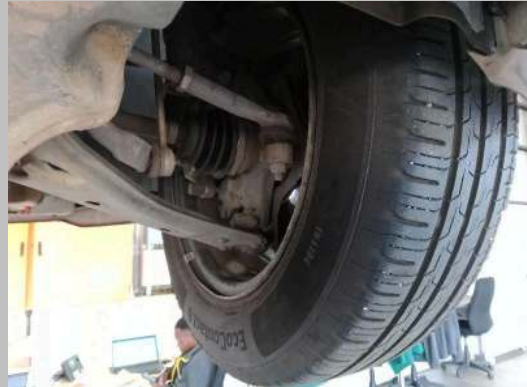
RF TYRE TREAD

| | Size | Load/Speed Index | Manufacture | Model | Type* | Production Date | Tread Depth (mm) |
|---|---|---|---|---|---|---|---|
| Front Right | 185/65R15 | 88H | Continental | Contact | V | 2819 | 3 mm |
