CONDITION REPORT

Report No: 2016368756

Vehicle Type	PASSENGER VEHICLE	Registered Owner	MFC AUCTION HOUSE
Manufacturer	AUDI	Registration Number	CF13GRGP
Model	A4	Register Number	
VIN	WAUZZZ8K6DA124505	Date Of First Licensing	
Engine Number		Last COR	
Doors	5	License Expiry Date	29/02/2024
Color	SILVER	Power / Displacement	
Year Model		Paint Finish	TWO COAT UNI
Km Reading	363,920 KM	Fuel	DIESEL
Cab / Body Type	SEDAN	Transmission	AUTOMATIC

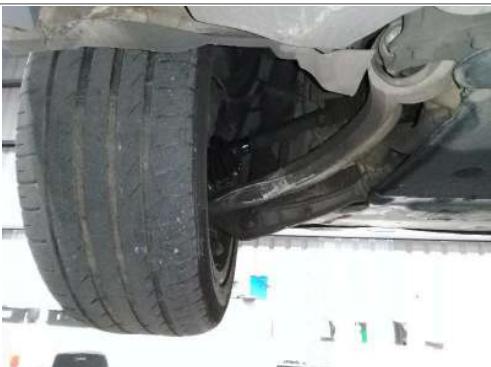
LF TYRE TREAD

Size	Load/Speed Index	Manufacture	Model	Type*	Production Date	Tread Depth (mm)
Front Left	225/50 R17	98W	Hifly	HF805	V	2622	0 mm
Front Right	225/50 R17	98W	Hifly	HF805	V	2622	1 mm
Rear Left	225/50 R17	94V	Michelin	Primacy	V	3919	1 mm
Rear Right	225/50 R17	94V	Michelin	Primacy	V	2921	2 mm
Spare	T125/70 R19	100M	Continental	Temporary	V	3410	4 mm

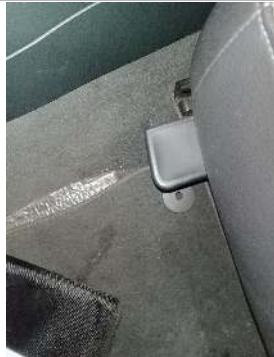
Front left bottom seat adjuste

Engine	Oil cooler dented
Undercarriage	Signs of oil leak on engine splash plate
Undercarriage	Bottom of engine and gearbox fully covered
Undercarriage	Cannot pin direction of oil leak
Undercarriage	Vehicle undercarriage dirty
Brakes	Front right brake disk dust plate damaged
Interior	Vehicle interior dirty and some panels scratched
Body and Exterior	Dents and scratches on some body panels
Body and Exterior	Stone chips and spray work on some body panels
Interior	Front left bottom seat adjuster handle damaged

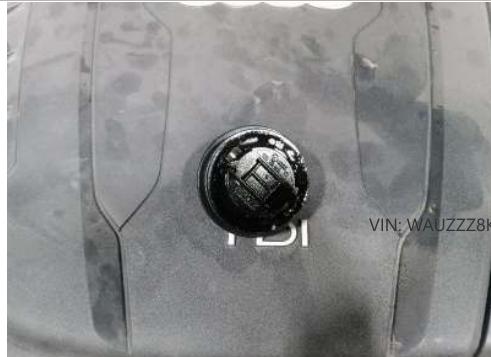
Oil cap

Damage	Repair Way
Windscreen Chipped	Repair
Caliper 1. Axle right Leak	Repair
Brake disc 2. Axle right Defective	Replace
Parking Brake Performance Left / Right Difference out of legal range	Repair
Control Arm Bush(es) Front Axle Left Cracked	Replace
Control Arm Bush(es) Front Axle Right Cracked	Replace
Ball Joint(s) Front Axle Right Defective	Replace
Tyre Front Left Worn	Replace
Tyre Rear Left Defective	Replace
Rim Front Left Scratched	Repair
Rim Front Right Scratched	Repair
Rim Rear Left Scratched	Repair
Rim Rear Right Scratched	Repair
Belly plates Damaged	Repair
Gearbox Mountings Defective	Repair
CV Joint(s) Boot(s) Front Left (inner/outer) Damaged	Replace
Triangle Missing	Replace
Electrical instruments and components	Vehicle electronics malfunctioning
Engine	Engine bay dirty and rust inside expansion bottle
Electrical instruments and components	Electronic parking brake switch malfunctioning
Electrical instruments and components	Oil measuring instrument faulty

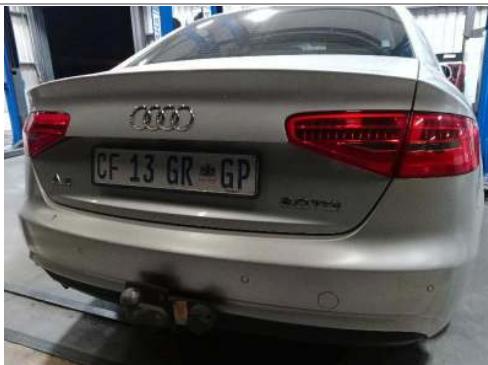
Door Front Right Paintwork • Scratched	Repair
Door Rear Right Dented	Repair
Boot Lid / Hatch door Paintwork • Scratched	Repair
Rear bumper Damaged	Repair

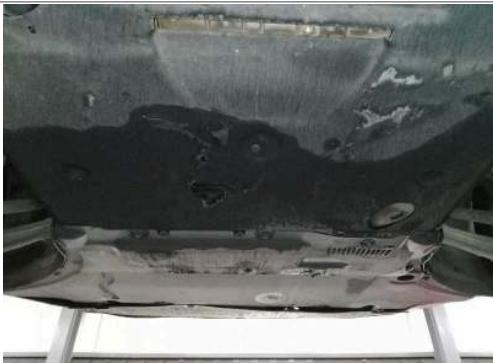
Damage	Repair Way
Engine Oil Leak	Repair
Hoses Oil Sweat	Repair
Center Console / Cubbyhole + Lid Damaged	Repair
Switch Electrical Window Winder front left Malfunction	Replace
Indicator Light Front Left Defective	Repair
Headlight Left Defective	Repair
Headlight Right Defective	Repair
Seat Front Right Damaged	Repair
Interior Mirror Missing	Replace
Sun Visor Right Broken	Replace
Door Handle Front Left Defective	Replace
Door Handle Front Right Defective	Repair
Door Handle Rear Right Defective	Repair
Door Sealing Rubber Front Right Damaged	Replace
Steering Wheel Trim Defective	Repair
Number Plate Front Dented	Repair
Side Mirror Left Paintwork • Scratched	Repair
Side Mirror Right Residual Traces of Repair	Repair
Front Bumper Damaged	Repair
Bonnet Damaged	Repair
Front Fender Left Paintwork • Scratched	Repair
Front Fender Right Paintwork • Scratched	Repair
Rear Fender Left Dented	Repair
Rear Fender Right Damaged	Repair
Door Front Left Paintwork • Scratched	Repair
