MFC Auction House
M57 Pretoria Rd, Glenmarais, KEMPTON PARK
Gauteng

DEKRA MFC
M57 Pretoria Rd - 1619
KEMPTON PARK - GT
08610 33572

CONDITION REPORT

Report No: 2016346670

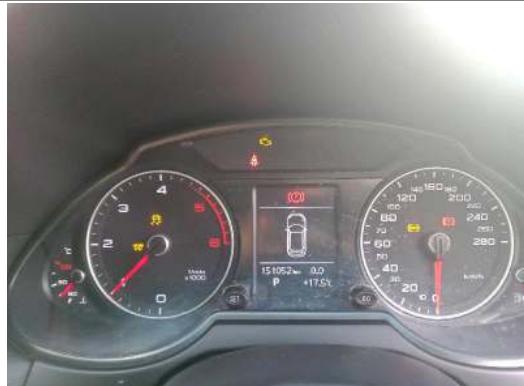
DASHBOARD (W/ ENGINE RUNNING)

Damage	Repair Way
Central Air Vent Damaged	Repair
Carpet Front Damaged	Repair
Side Mirror Left Damaged	Repair
Side Mirror Right Damaged	Replace
Front Bumper Damaged	Repair
Bonnet Damaged	Repair
Front Fender Left Damaged	Repair
Front Fender Right Damaged	Repair
Door Front Left Damaged	Repair
Door Front Right Damaged	Repair
Door Rear Left Damaged	Repair
Rear bumper Damaged	Repair
Shock Absorber Rear Right Leak	Replace
Tyre Front Left Worn	Replace
Tyre Front Right Worn	Replace
Some interior panels damaged	Replace
Some interior panels missing	Replace
Engine management lights illuminated	Repair
Electronic handbrake malfunctioning	Repair

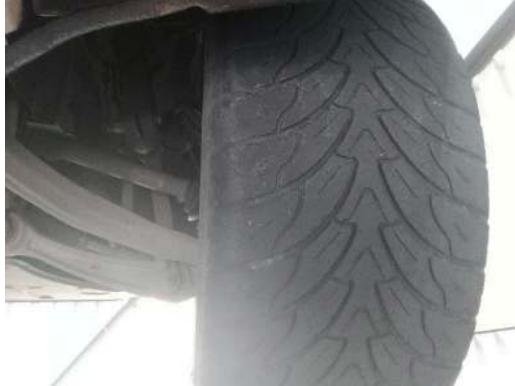
Tyre Front Right

Size	Load/Speed Index	Manufacture	Model	Type*	Production Date	Tread Depth (mm)
Front Left	275/35R20	102Y	Goodyear	Excellence	V	4920	0 mm
Front Right	275/40R20	106W	Federal	Radial	V	4810	0 mm
Rear Left	245/45R20	115R	Kumho	Radial	V	4420	0 mm
Rear Right	255/55R18	109V	Continental	Contisport	V	4214	0 mm
