## CONDITION REPORT

Report No:  
2016960881  
DATE  
28/07/2025

| Manufacturer | AUDI | Registration Number | KT09DBGP |
| Model | S3 SEDAN 2.0T FSI QUATTRO S TRONIC [2014-2014] | Register Number | |

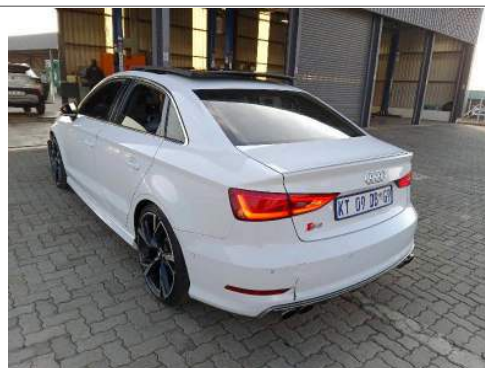
REAR LEFT CORNER

| Damage | Repair Way |
|---|---|
| Rear bumper Damaged | Repair |
| Rim Rear Left Dented | Repair |

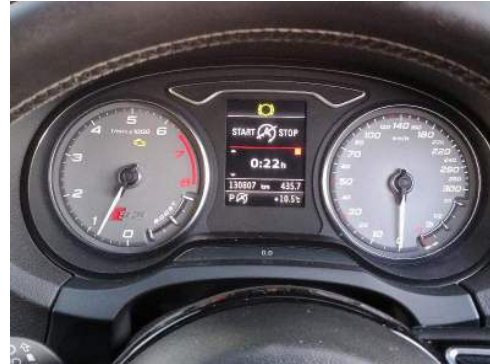
DASHBOARD (W/ ENGINE RUNNING)

| Damage | Repair Way |
|---|---|
| Warning lights illuminated | Repair |

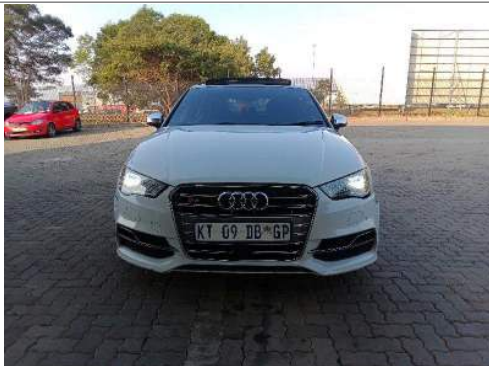
90 DEGREE FRONT

| Damage | Repair Way |
|---|---|
| Front Bumper Damaged | Repair |

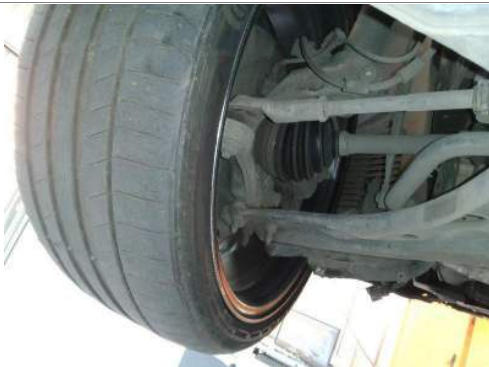
LF TYRE TREAD

| | Size | Load/Speed Index | Manufacture | Model | Type* | Production Date | Tread Depth (mm) |
|---|---|---|---|---|---|---|---|
| Front Left | 235/35R19 | 91Y | Continental | Contact | V | 0000 | 1 mm |

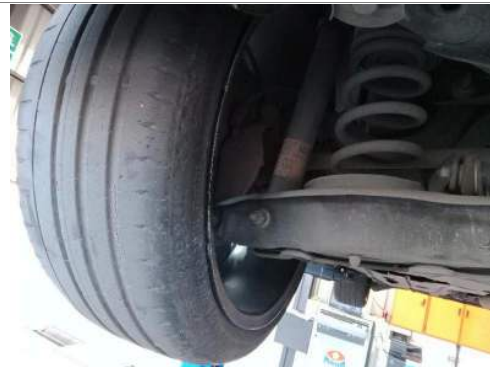
LR TYRE TREAD

| Damage | Repair Way |
|---|---|
| Tyre Rear Left Smooth | Replace |

| | Size | Load/Speed Index | Manufacture | Model | Type* | Production Date | Tread Depth (mm) |
|---|---|---|---|---|---|---|---|
| Rear Left | 235/35R19 | 91Y | Continental | Contact | V | 2222 | 0 mm |

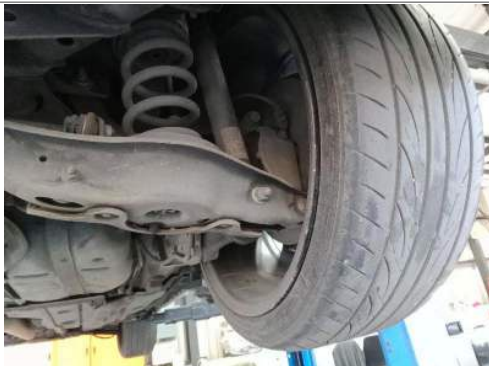
RR TYRE TREAD

| Damage | Repair Way |
|---|---|
| Tyre Rear Right Excessive Wear & Tear | Replace |

| | Size | Load/Speed Index | Manufacture | Model | Type* | Production Date | Tread Depth (mm) |
|---|---|---|---|---|---|---|---|
| Rear Right | 235/35R19 | 91W | Yokohama | Advance | V | 0000 | 2 mm |

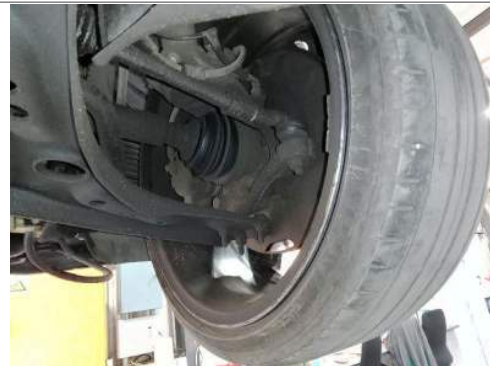
RF TYRE TREAD

| | Size | Load/Speed Index | Manufacture | Model | Type* | Production Date | Tread Depth (mm) |
|---|---|---|---|---|---|---|---|
| Front Right | 235/35R19 | 91Y | Goodyear | Eagle | V | 0000 | 2 mm |

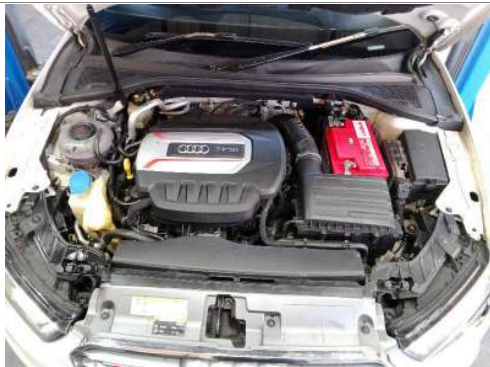
ENGINE 1

| Damage | Repair Way |
|---|---|
| Engine Oil Leak | Repair |
| Hoses Oil Leak | Repair |

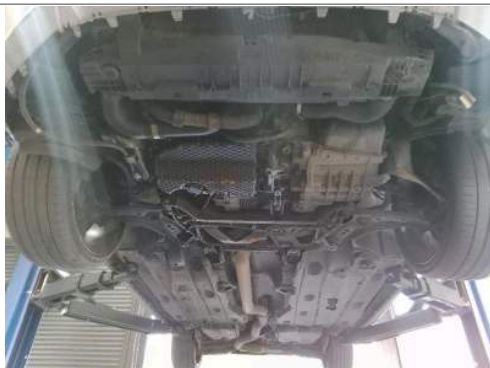
CHASSIS

| Damage | Repair Way |
|---|---|
| Engine to silencer pipe Welded | Replace |
