## CONDITION REPORT

Report No:  
2017304202  
DATE  
28/09/2026

| Manufacturer | BMW | Registration Number | LG66DXGP |
| Model | 118I HATCH 5-DR AT [2011-2016] | Register Number | |

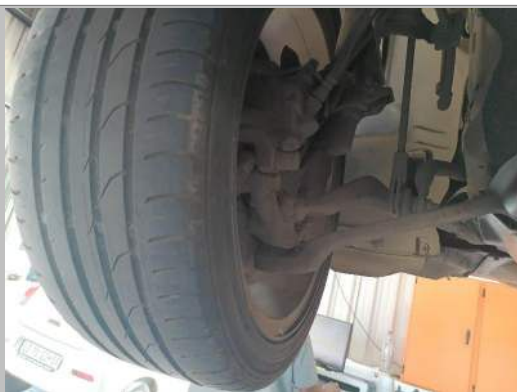
LF TYRE TREAD

| | Size | Load/Speed Index | Manufacture | Model | Type* | Production Date | Tread Depth (mm) |
|---|---|---|---|---|---|---|---|
| Front Left | 215/40R17 | 87W | Continental | Contact | V | 0123 | 2 mm |

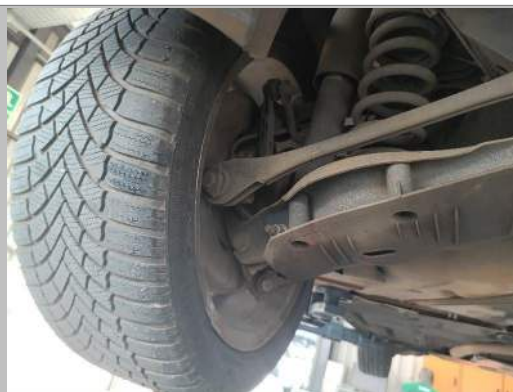
LR TYRE TREAD

| | Size | Load/Speed Index | Manufacture | Model | Type* | Production Date | Tread Depth (mm) |
|---|---|---|---|---|---|---|---|
| Rear Left | 225/45R17 | 91H | Bridgestone | LM | V | 1025 | 3 mm |

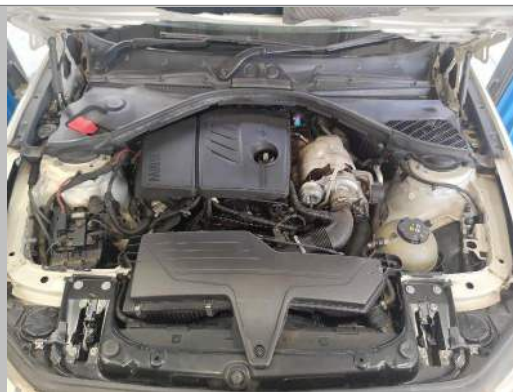
ENGINE 1

| Damage | Repair Way |
|---|---|
| Engine Oil Leak | Repair |
