## CONDITION REPORT

Report No: 2016839316

DATE  
11/04/2025

| Manufacturer | BMW | Registration Number | FZ89XHGP |

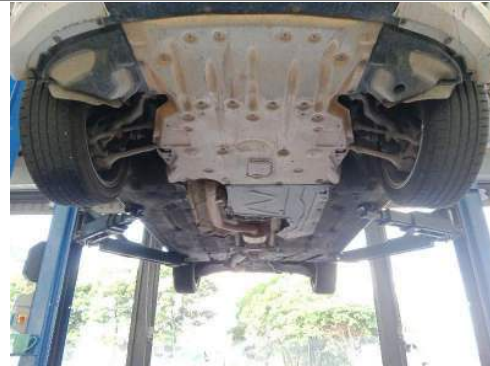
Front chassis

| Damage | Repair Way |
|---|---|
| Undercarriage | Front left jacking point bracket missing |
| Undercarriage | Front and rear jacking point brackets worn |

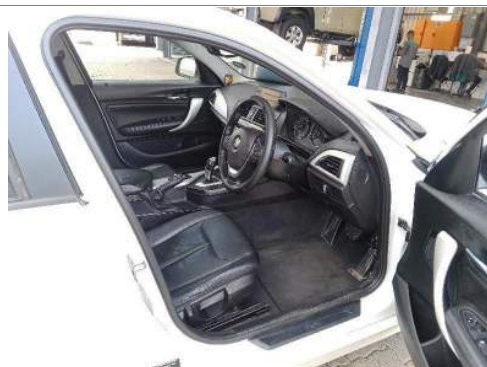
INTERIOR (FRONT DRIVER DOOR)

| Damage | Repair Way |
|---|---|
| Interior | Vehicle interior dirty and some panels scratched |
