CONDITION REPORT

Report No:
2016959304
DATE
26/07/2025

MFC Auction House
M57 Pretoria Rd, Glenmarais, KEMPTON PARK
Gauteng

Vehicle Type	PASSENGER VEHICLE	Registered Owner	MFC
Manufacturer	BMW	Registration Number	CZ21WYGP
Model	320I AT [2012-2016]	Register Number	
VIN	WBA3B16060NS53148	Date Of First Licensing	
Engine Number		Last COR	
Doors	4	License Expiry Date	31/10/2025
Color	SILVER	Power / Displacement	
Year Model	2014	Paint Finish	TWO COAT UNI
Km Reading	195,272 KM	Fuel	PETROL
Cab / Body Type	SEDAN	Transmission	AUTOMATIC

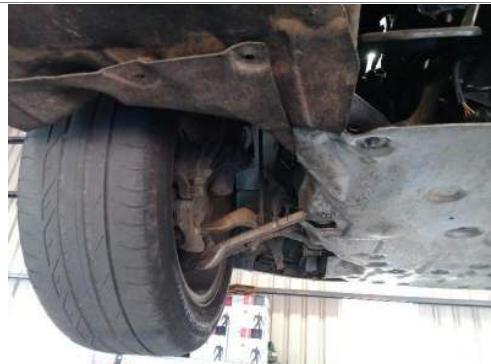
LF TYRE TREAD

Size	Load/Speed Index	Manufacture	Model	Type*	Production Date	Tread Depth (mm)
Front Left	225/50 R17	94W	Bridgestone	Potenza	V	2121	1 mm
Front Right	225/50 R17	94W	Bridgestone	Turanza	V	4021	0 mm
Rear Left	225/50 R17	94W	Bridgestone	Potenza	V	4417	0 mm
Rear Right	225/50 R17	94W	Bridgestone	Turanza	V	2619	0 mm
