MFC Auction House
M57 Pretoria Rd, Glenmarais, KEMPTON PARK
Gauteng

DEKRA MFC
M57 Pretoria Rd - 1619
KEMPTON PARK - GT
08610 33572

VEHICLE INSPECTION

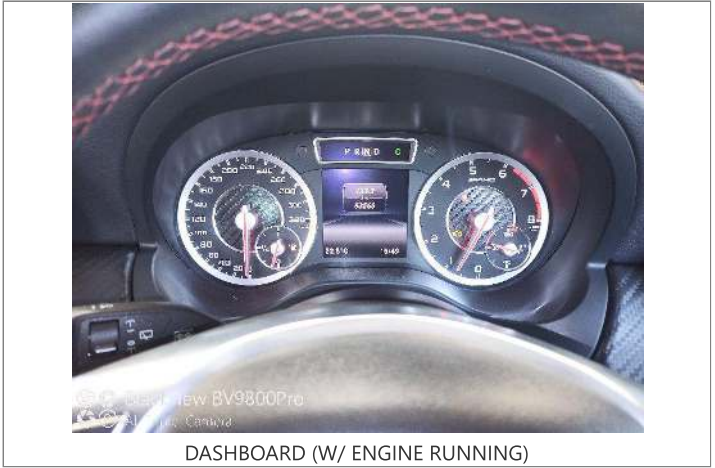
DASHBOARD (W/ ENGINE RUNNING)

Damage	Repair Way
Front Bumper Paintwork • Scratched	Repair
Front Fender Right Paintwork • Scratched	Repair
Door Front Left Paintwork • Chipmarks	Repair
Door Front Right Paintwork • Chipmarks	Repair
Rear bumper Paintwork • Scratched	Repair
Windscreen Cracked	Replace
Tyre Front Right Damaged	Replace
Tyre Rear Right Smooth	Replace
No license dice	Replace
Engine management lights illuminated	Repair

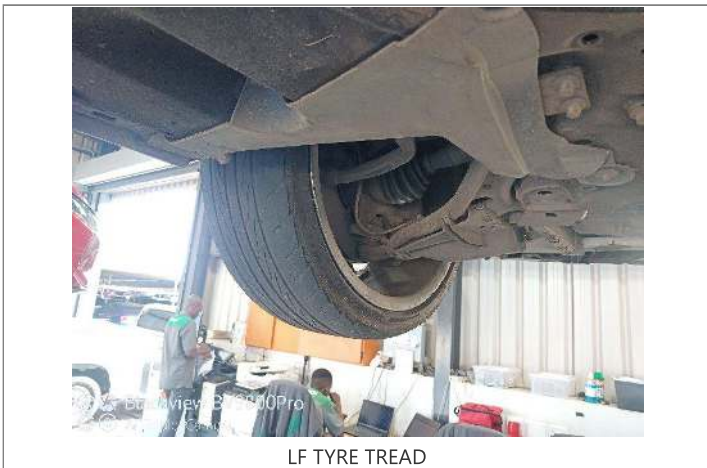
LF TYRE TREAD

Size	Load/Speed Index	Manufacture	Model	Type*	Production Date	Tread Depth (mm)
Front Left	235/35R19	91W	Mazzini	Eco607	V	4320	1 mm
Front Right	235/35R19	91Y	Continental	Contact	V	1921	0 mm
Rear Left	235/35R19	91Y	Yokohama	Advan sport	V	4816	2 mm
Rear Right	235/35R19	91Y	Continental	Contact	V	0819	0 mm
